# Sample Fire Report

Street Address  
City, State, Zip

Incident Date: 7/15/05

Date: 11/20/05

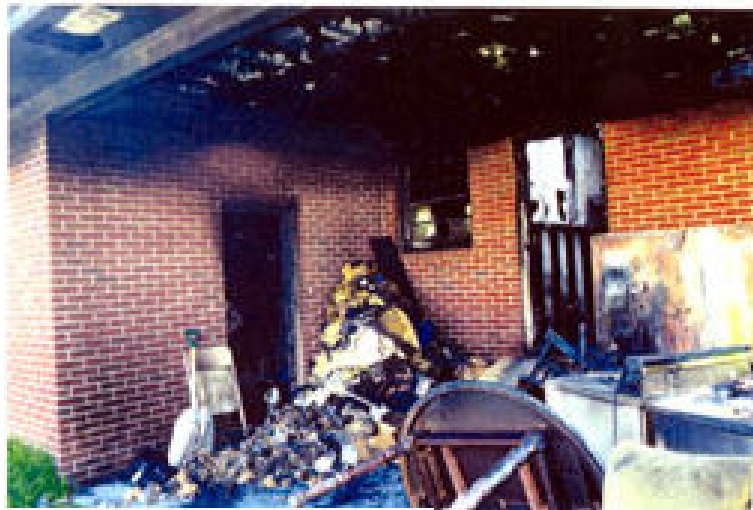
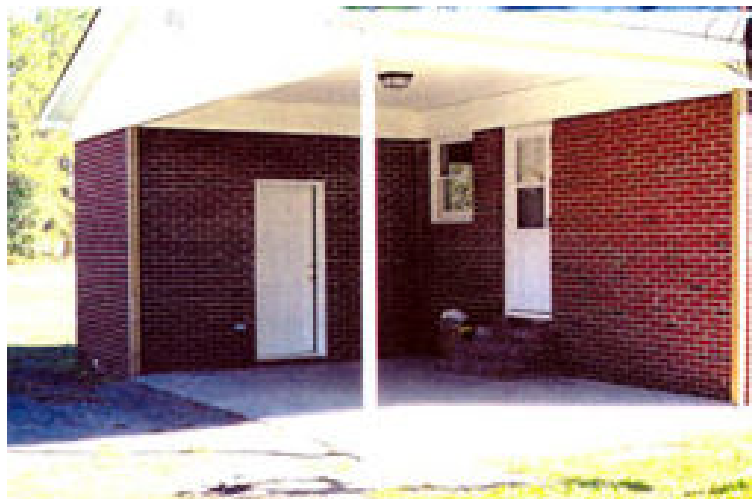
Location: Exterior

Room: Patio Area off Kitchen and Storage Room

Loss: Extensive Damage

Extensive structural damage to the homes ceiling joist and rafter systems was evident. Structural repairs were required to reinforce weakened roof structure. Smoke and water damage was moderate and required water extraction cleaning, sealing. Exterior finishes of siding, trim, soffits and ceilings required total replacement.

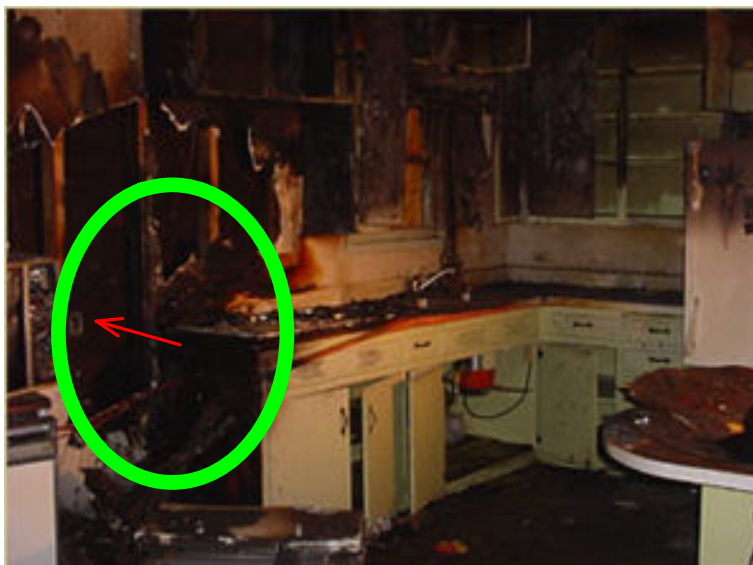
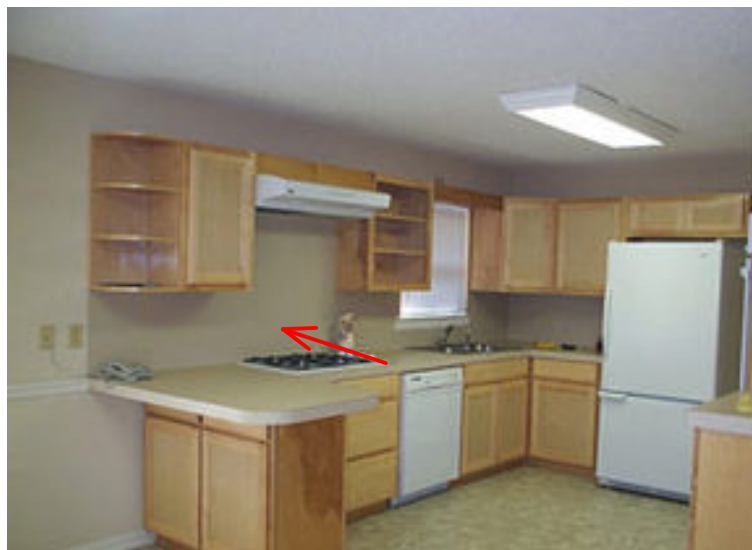
Location: Interior 1st Floor

Room: Kitchen

Loss: Moderate

Fire originated from faulty electrical outlet (highlighted) behind cooking range. Fire was isolated quickly with minimal structural damage to the load bearing exterior wood framed wall. Fire damaged the cabinetry beyond salvage. Walls, ceiling and floors all sustained water and smoke damage.

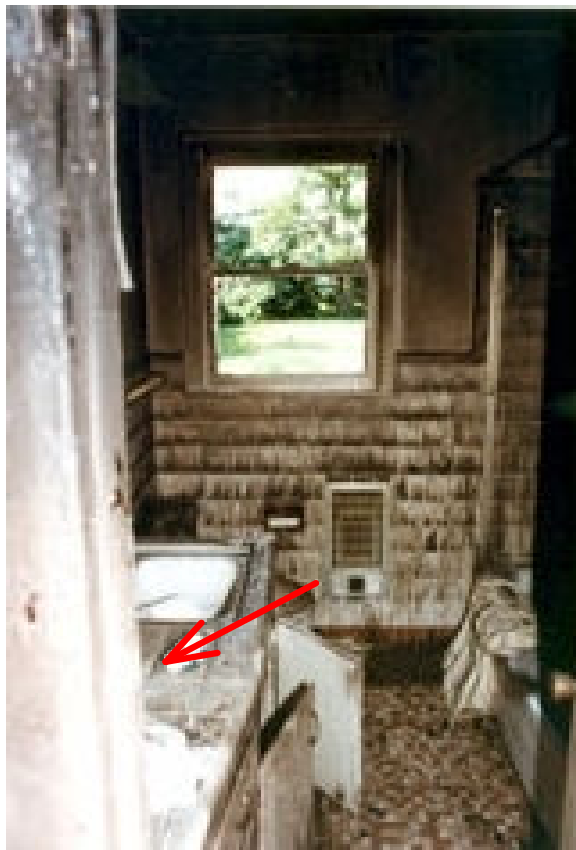
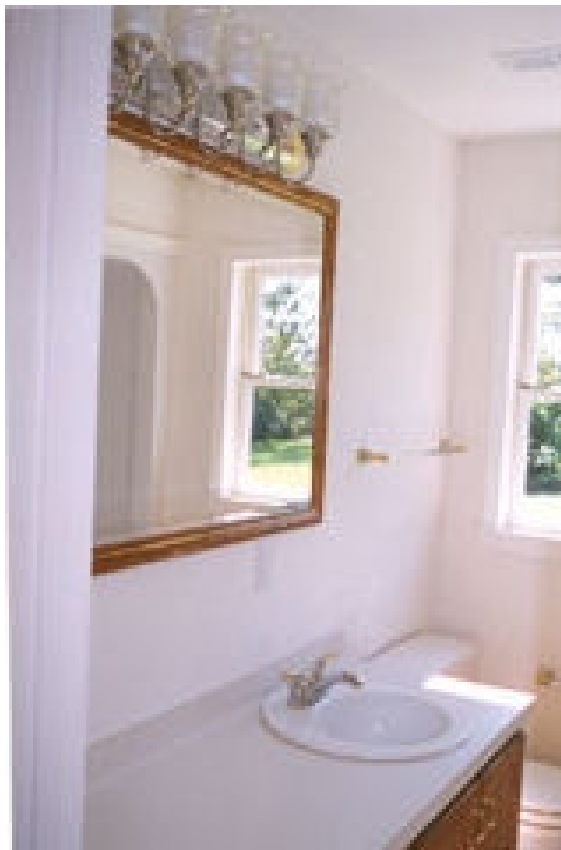
Location: Interior 1st Floor

Room: Bathroom

Loss: Moderate

Fire originated at faulty curling iron on vanity cabinet (location referenced). Fire damage was minimal with mostly smoke damage. Bath required water extraction, cleaning and sealing. Fixtures were replaced.

Floor tile was salvaged but required cleaning.
