Sample Forensic Report

1234 Madison Rd.
Anywhere, US 12345

Prepared for: John Smith

Date: July 7, 2005
Time: 7:17 am
Ambient Temperature: 45*
Wind Speed: 2.5 mph
Relative Humidity: 30*

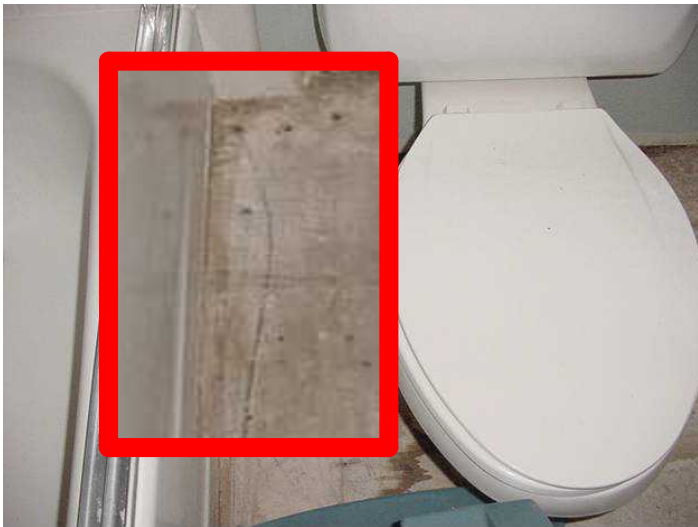
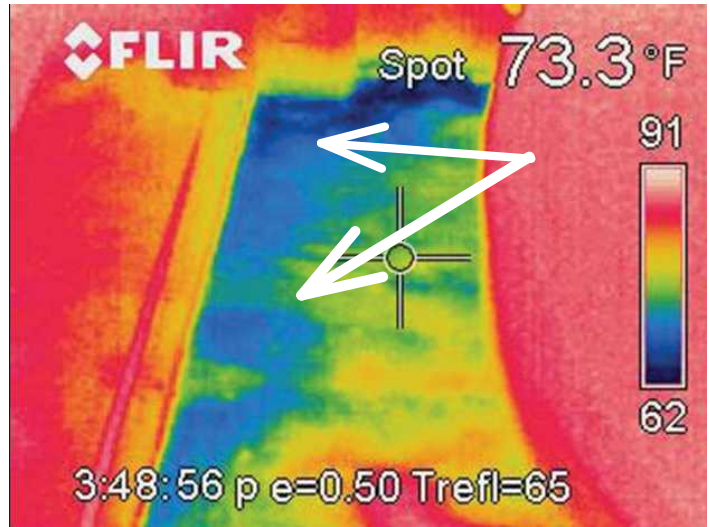
Floor: Interior
Location: 2nd Floor
Equipment: Flir ThermaCAM B2

Concerns:
Water damage detected from toilet leaking condition. Corrections are required to floor system including dry out and sanitizing.

Problem: Water damage detected from toilet leaking condition. Corrections are required to floor system including dry out and sanitizing.

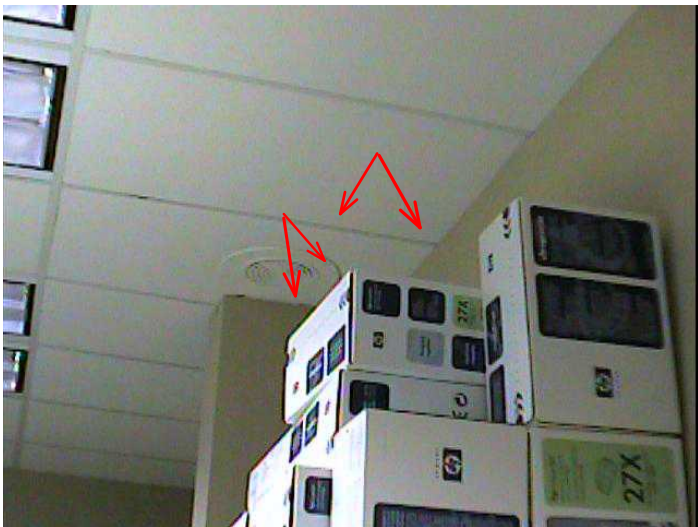
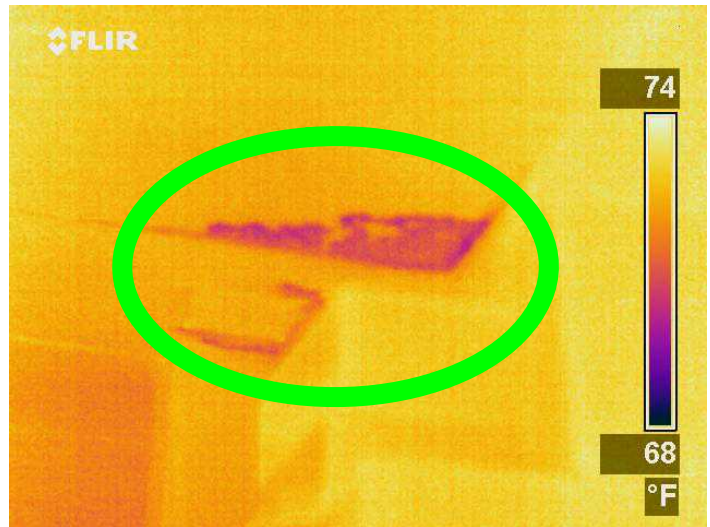
Floor: Interior
Location: Storage room
Equipment: Flir ThermaCAM B2

Concerns:
Water intrusion confirmed, Investigate and perform appropriate repair.

Problem: Water intrusion confirmed, Investigate and perform appropriate repair.

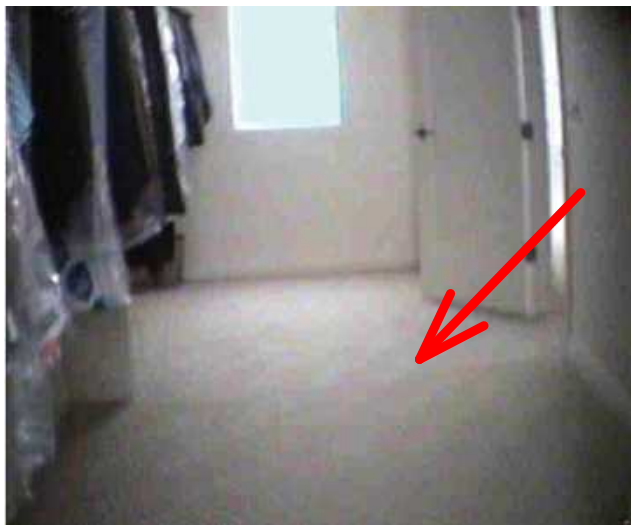
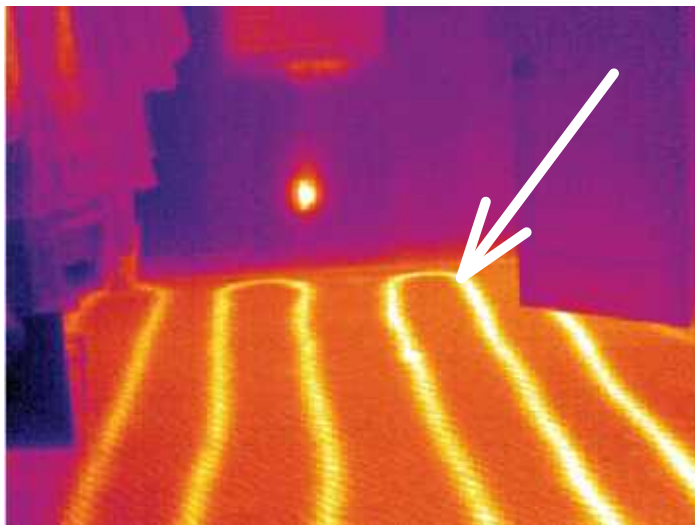
Floor: Interior
Location: Master Closet
Orientation: South exterior wall
Equipment: Flir ThermaCAM B2

Concerns:
Noted in-floor convection heating system.

Problem: Noted in-floor convection heating system.

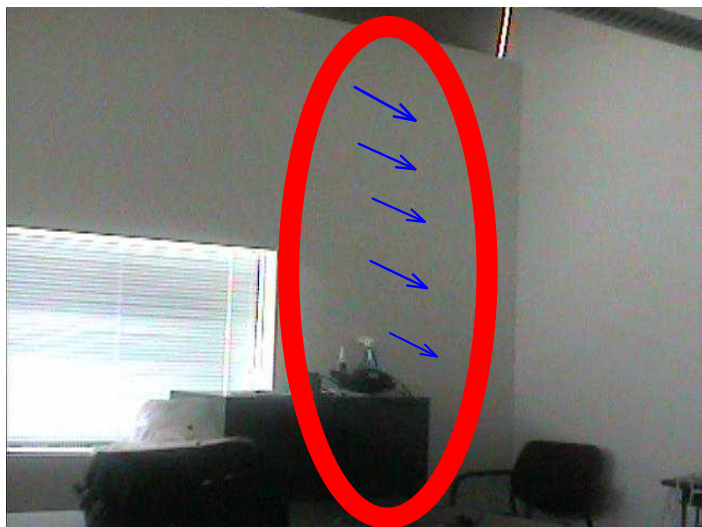
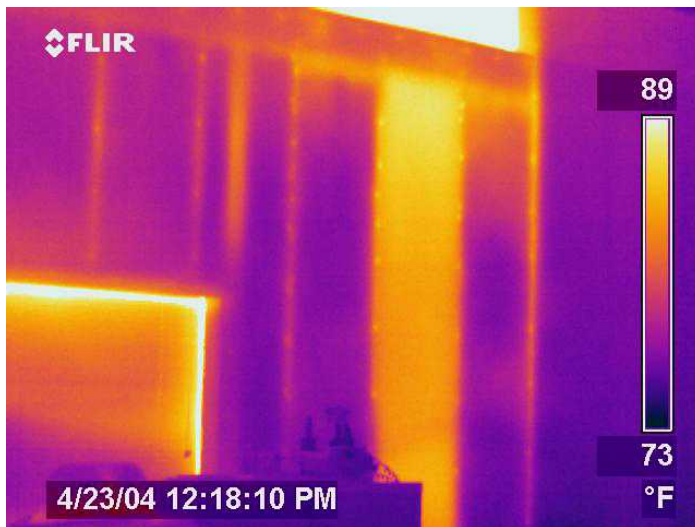
Floor: Interior
Location: Living Room
Orientation: South Exterior Wall
Equipment: Flir ThermaCAM B2

Concerns:
Insulation missing in wall cavity

Problem: Insulation missing in wall cavity

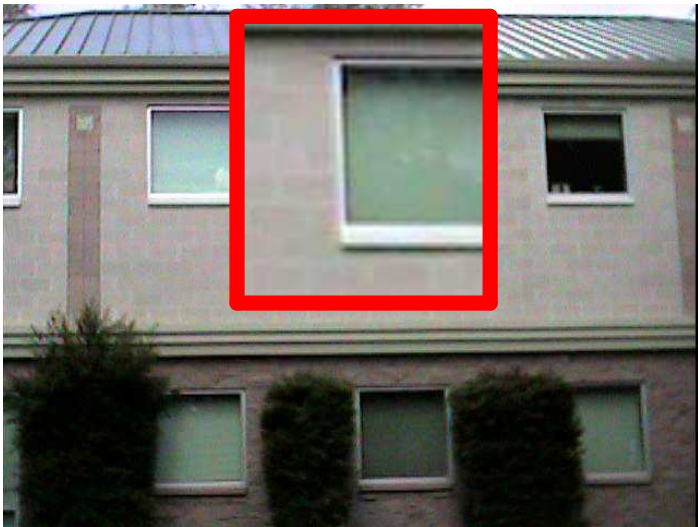
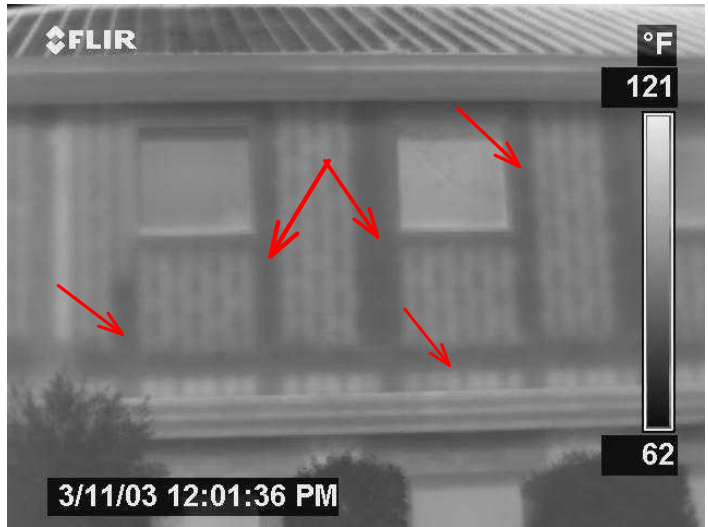
Floor: Exterior
Location: Rear
Orientation: South Exterior
Equipment: Flir ThermaCAM B2

Concerns:
Mortar missing in wall brick cavities

Problem: Mortar missing in wall brick cavities

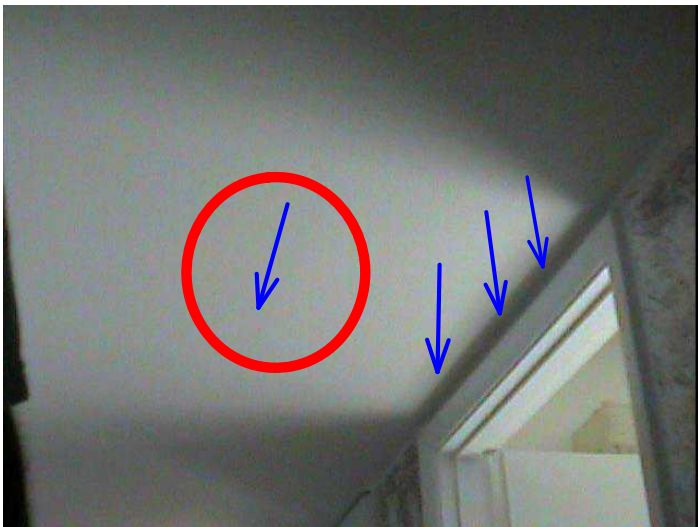
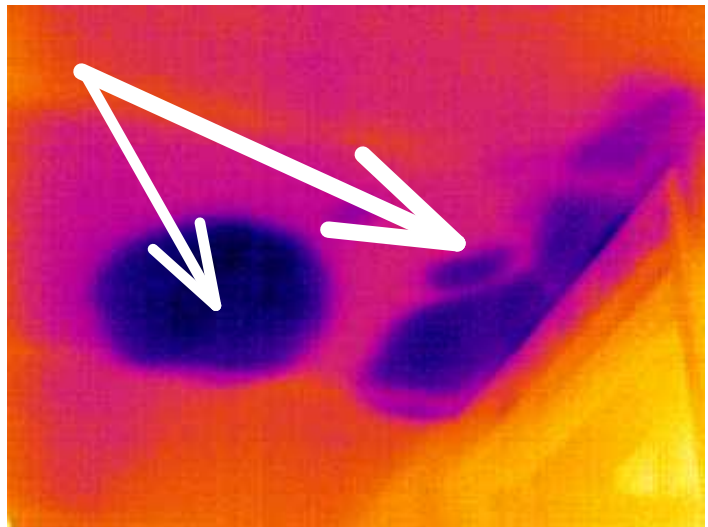
Floor: Interior
Location: Bathroom 2nd Floor
Equipment: Flir ThermaCAM B2

Concerns:
Water intrusion confirmed, Investigate and perform appropriate repair.

Problem: Water intrusion confirmed, Investigate and perform appropriate repair.

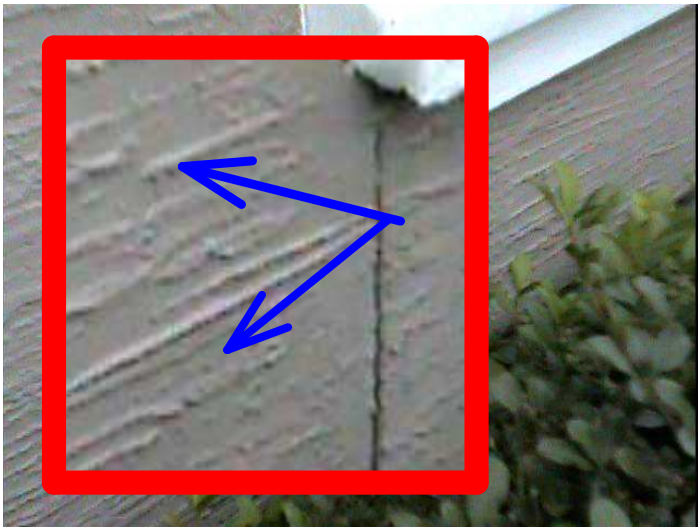
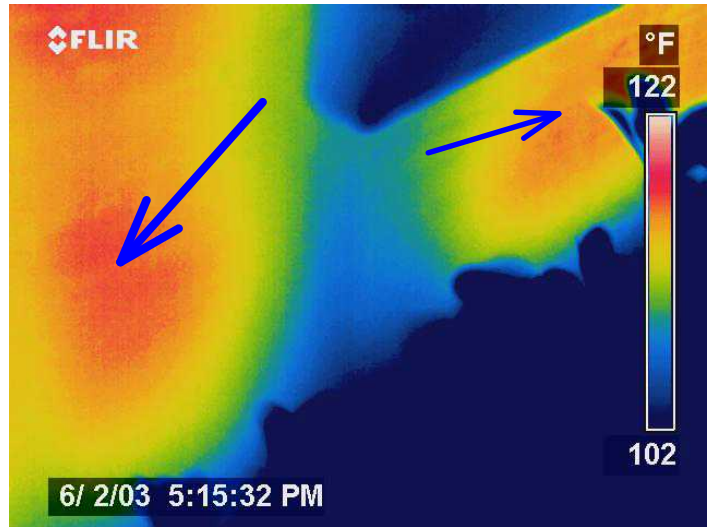
Floor: Exterior
 Location: Living Room Window
 Orientation: South wall
 Equipment: Flir ThermaCAM B2

Concerns:
 Insulation missing in wall cavity

Problem: Insulation missing in wall cavity
