# Sample Roof Survey

Prepared for: Your Client

Prepared by: Your Company Name Here  
1234 Any Street  
Anywhere, US 12345  
Initial Inspection

Date: 7/15/05  
Time: 5:00 pm  
Ambient Temperature: 90\*  
Wind Speed: 2.5 mph  
Relative Humidity: 75%

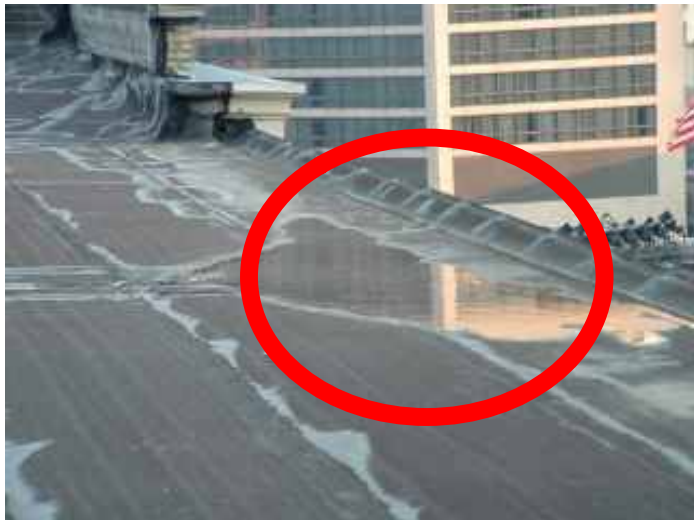
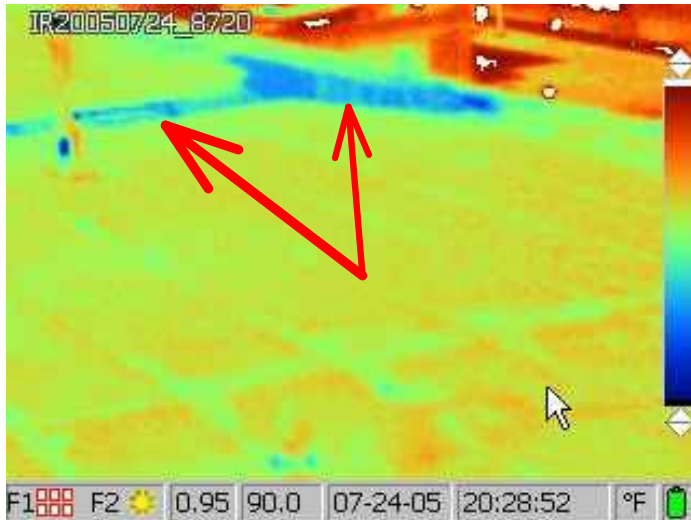
Location: Roof  
Orientation: East  
Delta Temperature: 30 Degrees  
Equipment: ThermalScan IRC-3000

Observations:  
Water intrusion confirmed , Investigate and perform appropriate repair.

Location:Roof - Orientation:East - Delta Temperature:30 Degrees  
Equipment: ThermalScan IRC-3000  
Problem: Water intrusion confirmed , Investigate and perform appropriate repair.

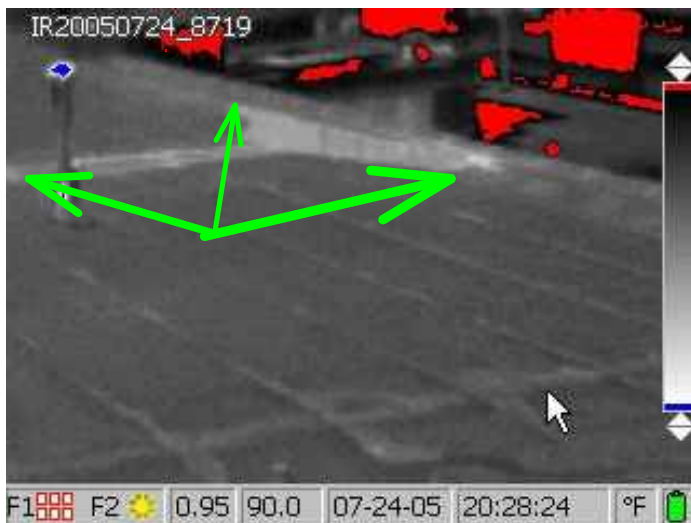
Observations:  
See set above for documentation. Water intrusion confirmed, Investigate and perform appropriate repair.

Problem: See set above for documentation. Water intrusion confirmed,Investigate and perform appropriate repair.

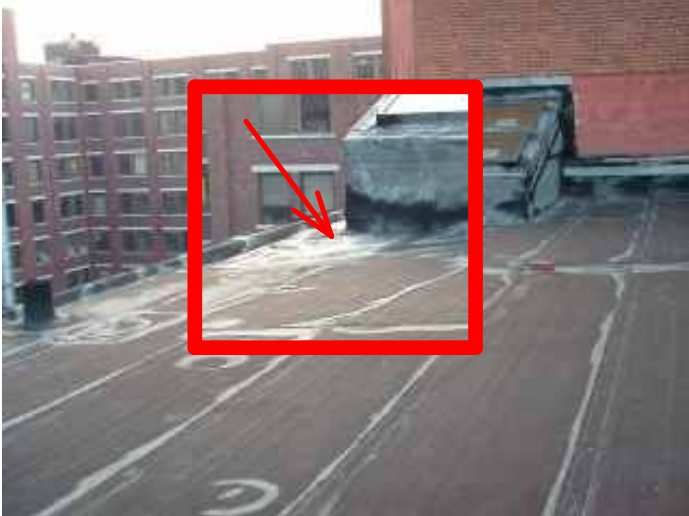
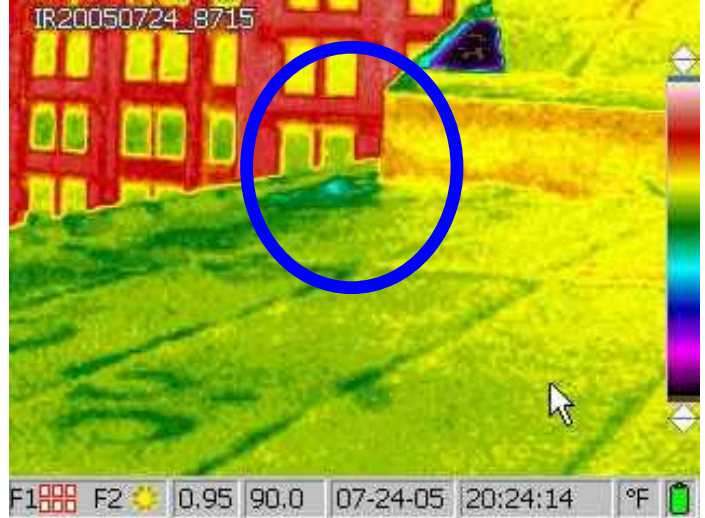
Location: Roof  
Orientation: South  
Delta Temperature: 30 Degrees  
Equipment: ThermalScan IRC-3000

Moisture appears to be indicated, Water intrusion confirmed, Investigate and perform appropriate repair.

Location:Roof - Orientation:South - Delta Temperature:30 Degrees  
Equipment: ThermalScan IRC-3000  
Problem: Moisture appears to be indicated, Water intrusion confirmed,Investigate and perform appropriate repair.

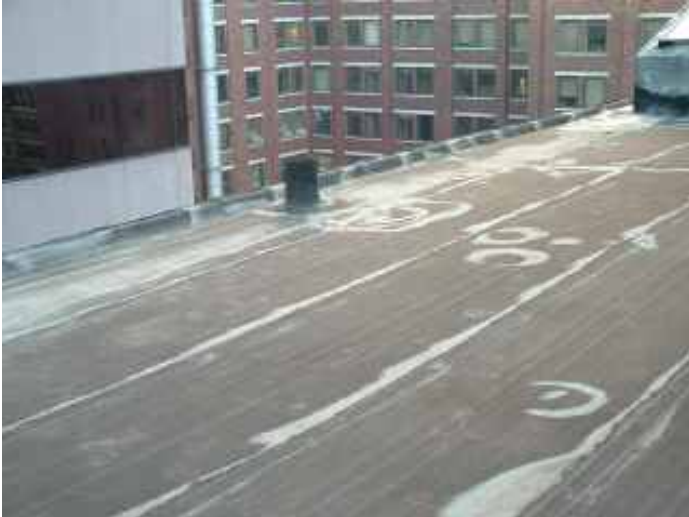
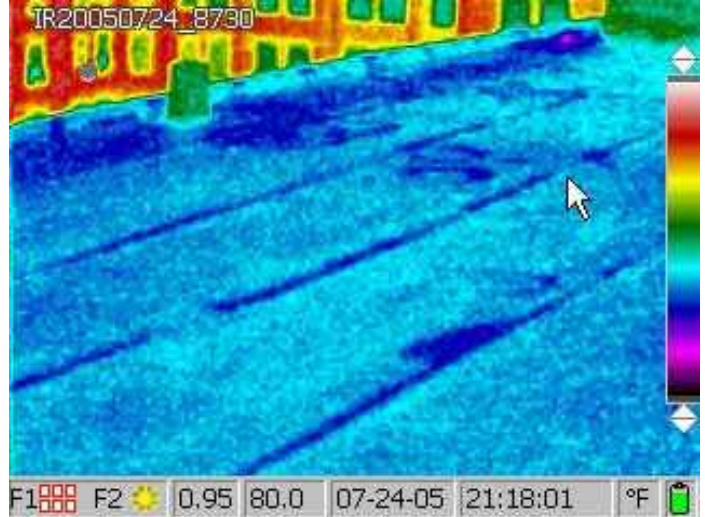
Location: Roof  
Orientation: East  
Delta Temperature: 30 Degrees  
Equipment: ThermalScan IRC-3000

No unusual findings apparent.

Location:Roof - Orientation:East - Delta Temperature:30 Degrees  
Equipment: ThermalScan IRC-3000  
Problem: No unusual findings apparent.

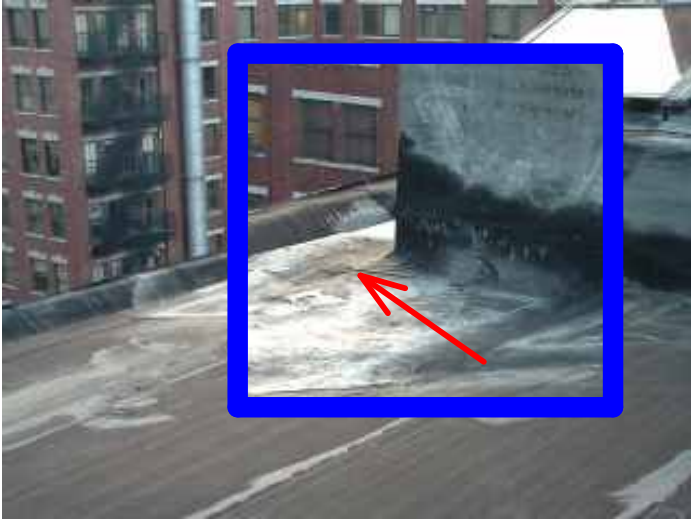
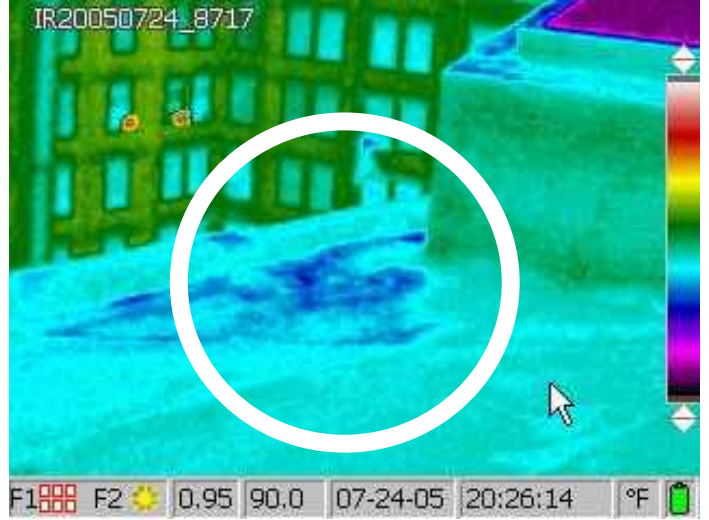
Location: Roof  
Orientation: East  
Delta Temperature: 30 Degrees  
Equipment: ThermalScan IRC-3000

Water intrusion confirmed, Investigate and perform appropriate repair.

Location:Roof - Orientation:East - Delta Temperature:30 Degrees  
Equipment: ThermalScan IRC-3000  
Problem: Water intrusion confirmed,Investigate and perform appropriate repair.

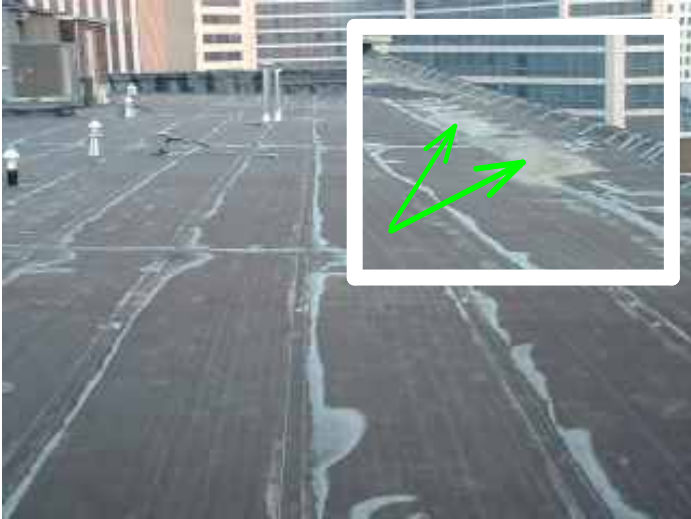
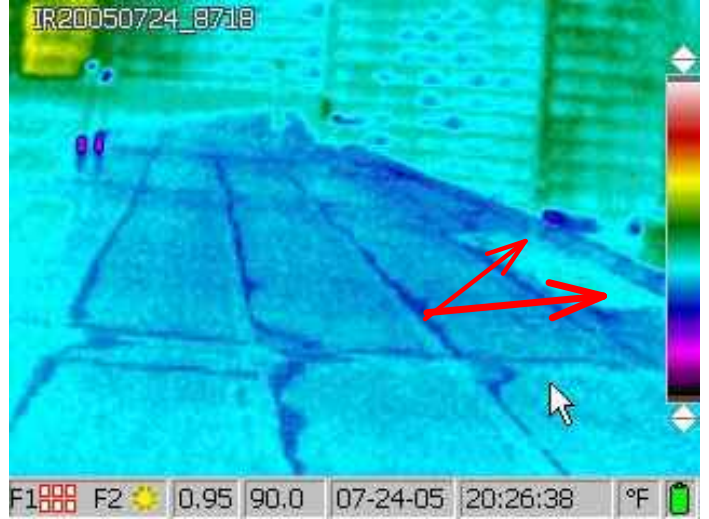
Location: Roof  
Orientation: West  
Delta Temperature: 30 Degrees  
Equipment: ThermalScan IRC-3000

Water intrusion confirmed, Investigate and perform appropriate repair.

Location:Roof - Orientation:West - Delta Temperature:30 Degrees  
Equipment: ThermalScan IRC-3000  
Problem: Water intrusion confirmed,Investigate and perform appropriate repair.

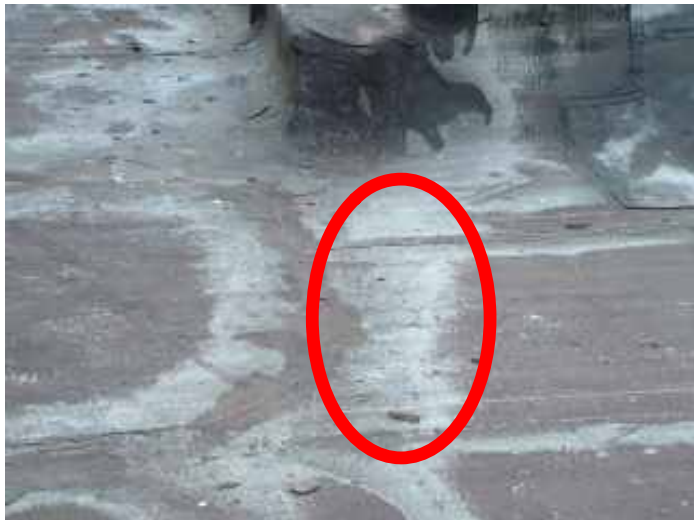
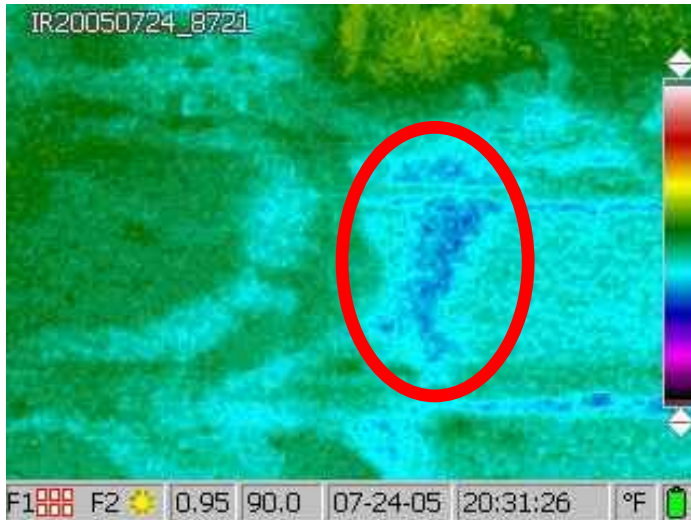
Location: Roof  
Orientation: South  
Delta Temperature: 30 Degrees  
Equipment: ThermalScan IRC-3000

Observations:  
Water intrusion confirmed near flashing target at base of scuttle curb ,Investigate and perform appropriate repair.

Location:Roof - Orientation:South - Delta Temperature:30 Degrees  
Equipment: ThermalScan IRC-3000  
Problem: Water intrusion confirmed near flashing target at base of scuttle curb ,Investigate and perform appropriate repair.

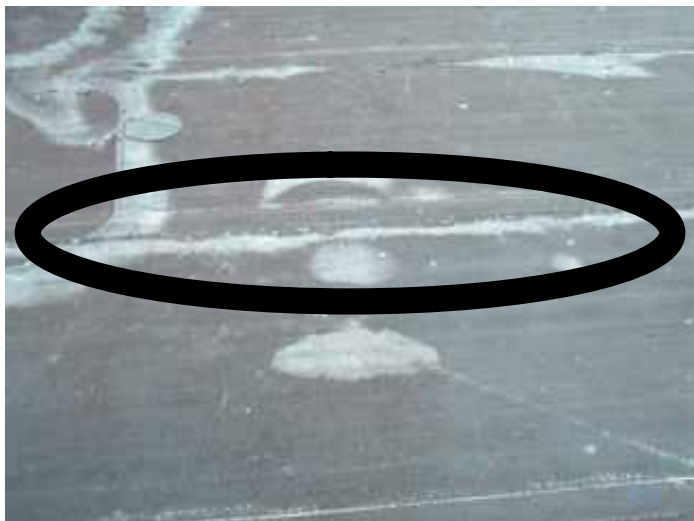
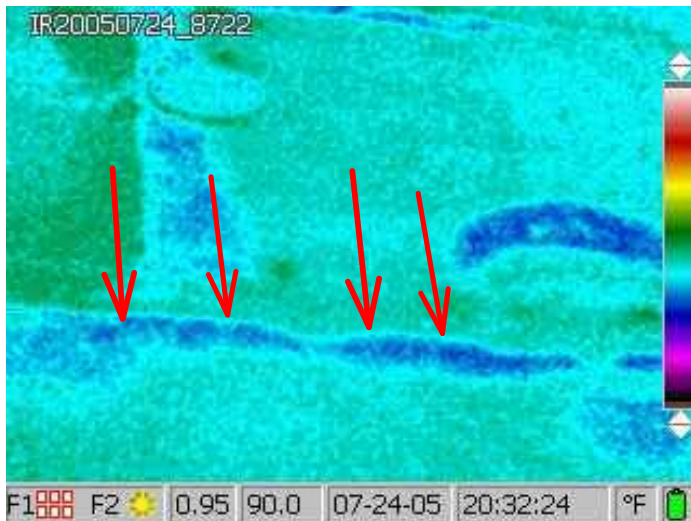
Location: Roof  
Orientation: South  
Delta Temperature: 30 Degrees  
Equipment: ThermalScan IRC-3000

Observations:  
Raised areas noted due to poor installation. Investigate and perform appropriate repair.

Location:Roof - Orientation:South - Delta Temperature:30 Degrees  
Equipment: ThermalScan IRC-3000  
Problem: Raised areas noted due to poor installation. Investigate and perform appropriate repair.

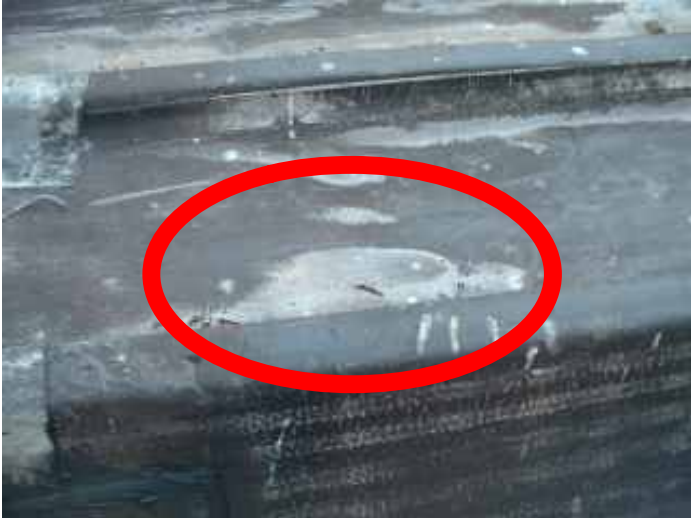
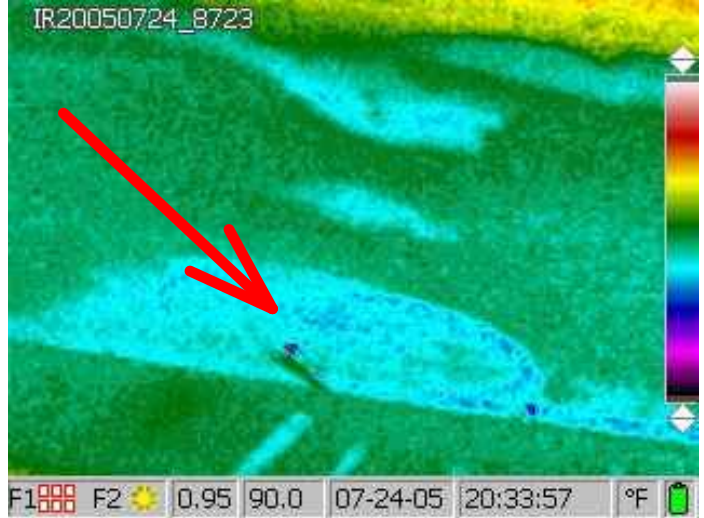
Location: Roof  
Orientation: South  
Delta Temperature: 30 Degrees  
Equipment: ThermalScan IRC-3000

Observations:  
no unusual findings with regards to leaking, although puddling is noted.

Location:Roof - Orientation:South - Delta Temperature:30 Degrees  
Equipment: ThermalScan IRC-3000  
Problem: no unusual findings with regards to leaking, although puddling is noted.

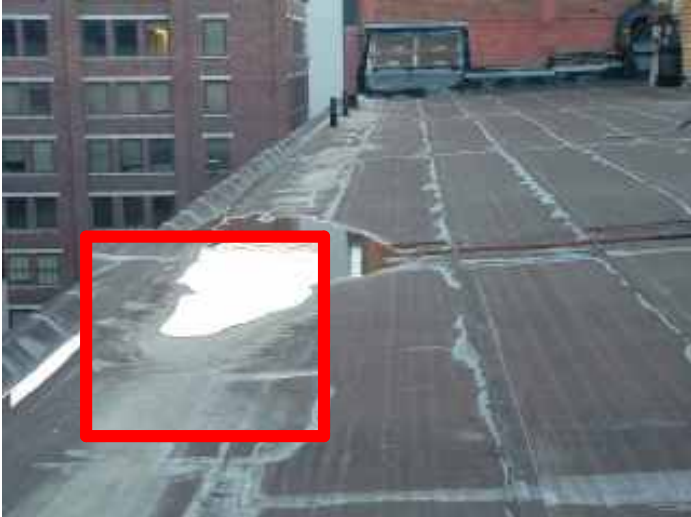
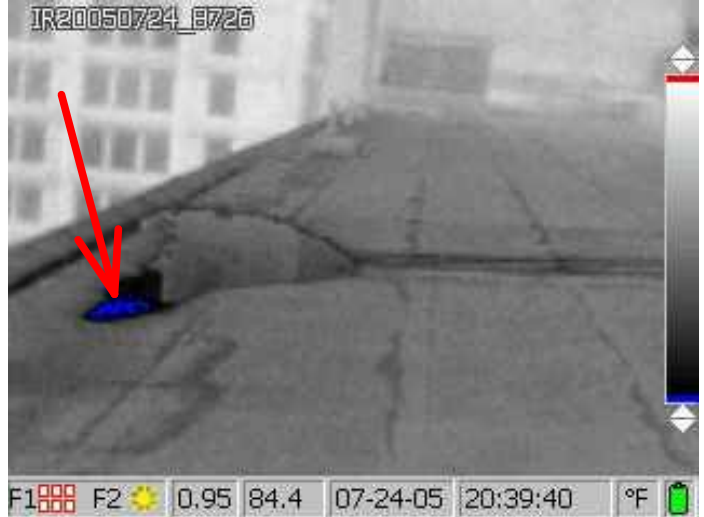
Location: Roof  
Orientation: North  
Delta Temperature: 30 Degrees  
Equipment: ThermalScan IRC-3000

Observations:  
Water intrusion confirmed, Investigate and perform appropriate repair.

Location:Roof - Orientation:North - Delta Temperature:30 Degrees  
Equipment: ThermalScan IRC-3000  
Problem: Water intrusion confirmed,Investigate and perform appropriate repair.
