# Sample Restoration Report

12345 Anywhere  
Anytown, US 23450

Date:8/15/05  
Time:8:00 am  
Ambient Temperature:40 degrees  
Wind Speed:2.5 mph  
Relative Humidity:40%

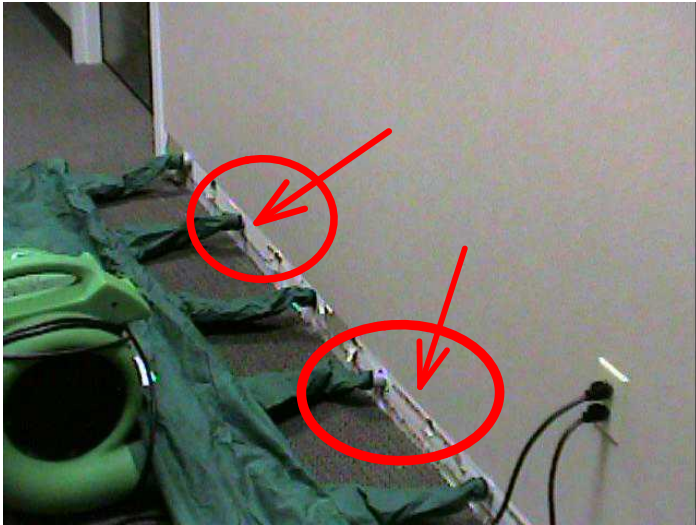
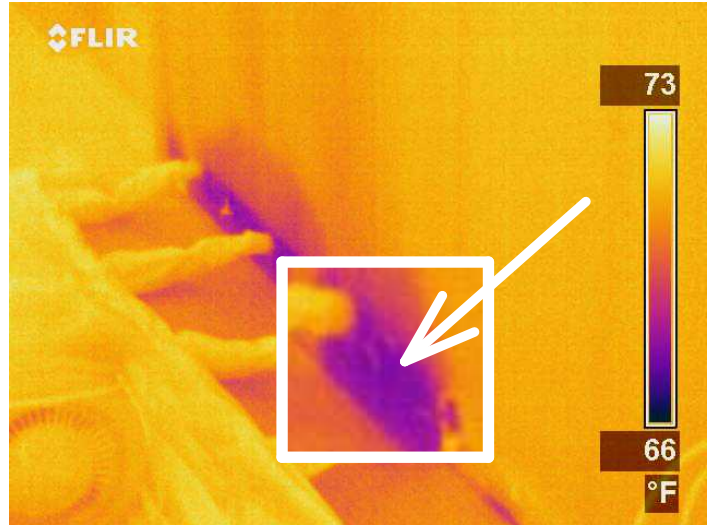
Floor: Concrete with Carpet Covering  
Location: Basement  
Orientation: North Wall  
Equipment: Flir B2

Concerns:  
Moisture concerns detected. Dry out in progress.

Floor:Concrete with Carpet Covering - LocationBasement - Orientation:North Wall  
Equipment: Flir B2  
Problem: Moisture concerns detected. Dry out in progress.

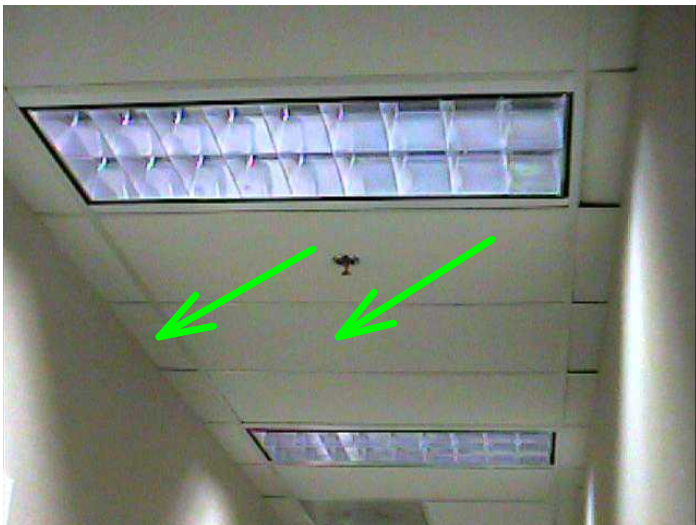
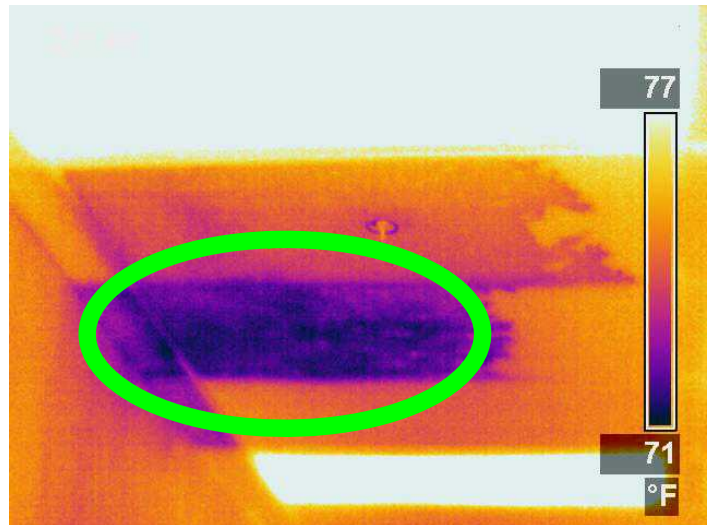
Floor: 1st Floor  
Location: Office Main Hall  
Orientation: North Hall  
Equipment: Flir B2

Concerns:  
Moisture concerns detected. , Further investigation required to determine water source.

Floor:1st Floor - LocationOffice Main Hall - Orientation:North Hall  
Equipment: Flir B2  
Problem: Moisture concerns detected. , Further investigation required to determine water source.

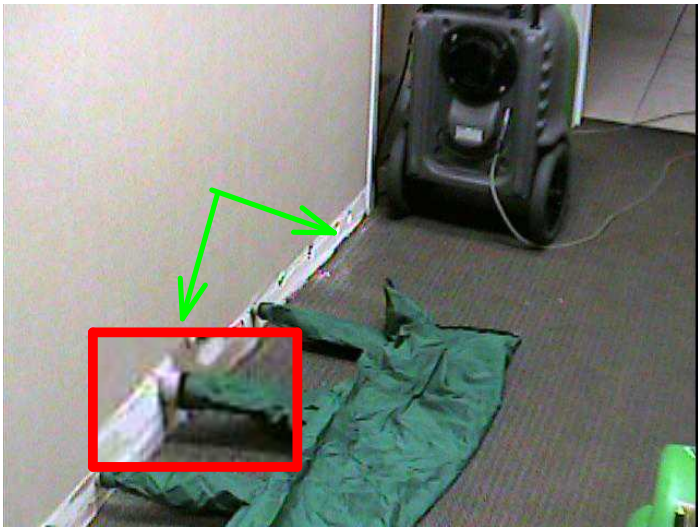
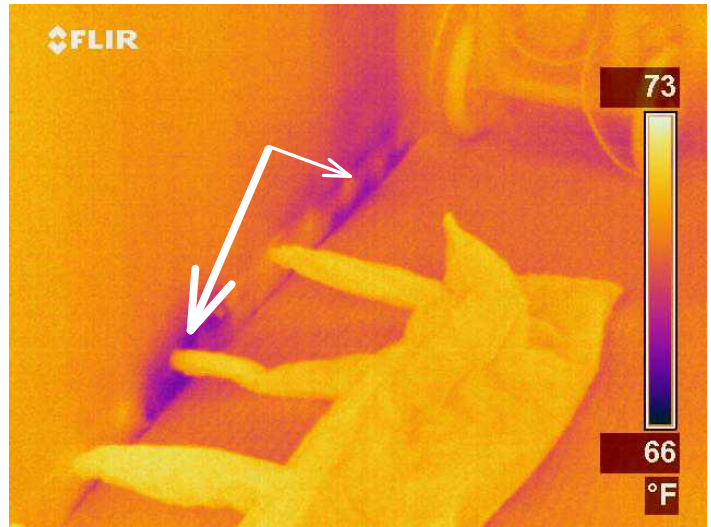
Floor: 1st Floor  
Location: Office  
Orientation: North  
Equipment: Flir B2

Concerns:  
Moisture concerns detected. Dry out in progress.

Floor:1st Floor - LocationOffice - Orientation:North  
Equipment: Flir B2  
Problem: Moisture concerns detected. Dry out in progress.

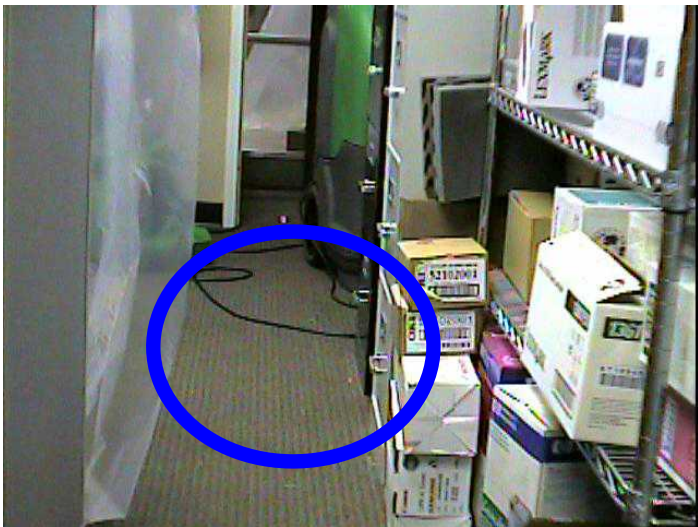
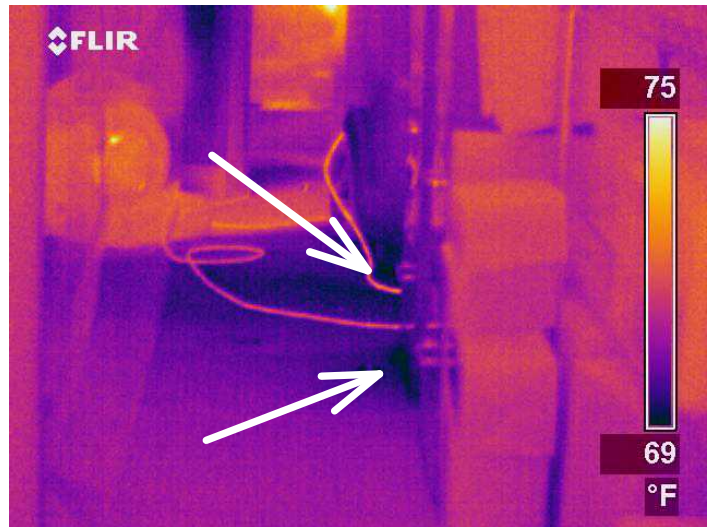
Floor: 1st Floor  
Location: Supply Room  
Orientation: East  
Equipment: Flir B2

Concerns:  
Moisture damage in wall and shown here at carpet near filing cabinets

Floor:1st Floor - LocationSupply Room - Orientation:East  
Equipment: Flir B2  
Problem: Moisture damage in wall and shown here at carpet near filing cabinets

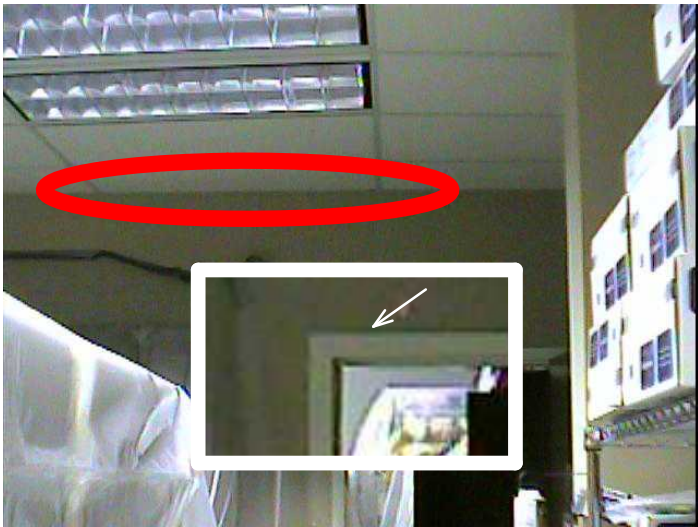
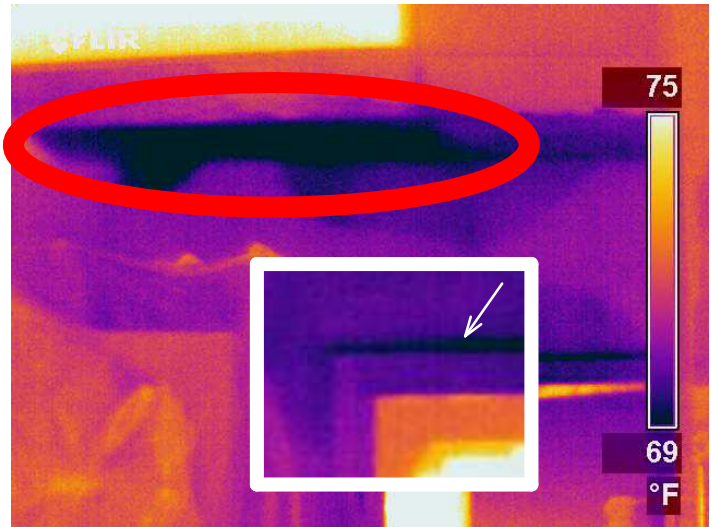
Floor: 1st Floor  
 Location: Storage Room  
 Orientation: West  
 Equipment: Flir B2

**Concerns:**  
 Further investigation of wall cavity and above ceiling to determine water source and extent of damage at door framing

Floor:1st Floor - LocationStorage Room - Orientation:West  
Equipment: Flir B2  
Problem: Further investigation of wall cavity and above ceiling to determine water source and extent of damage at door framing

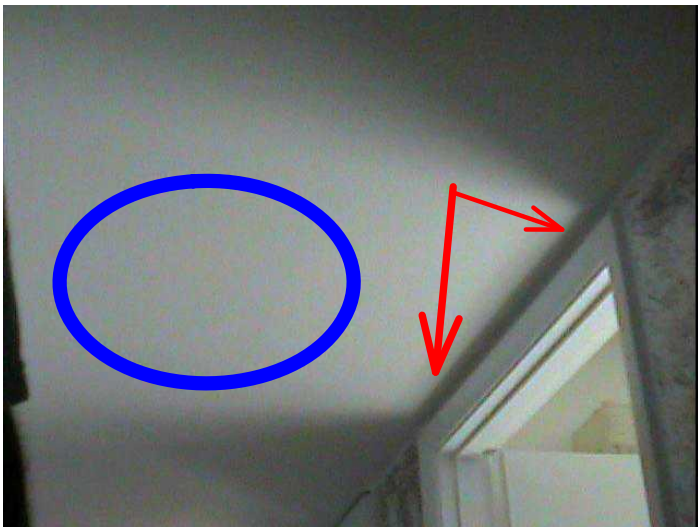
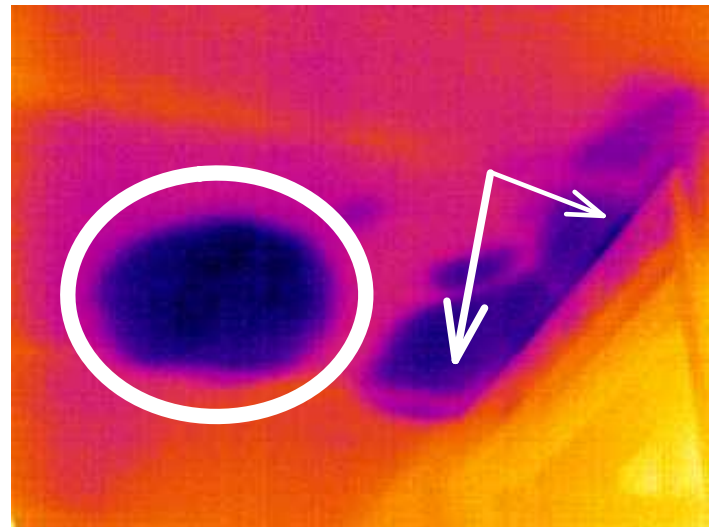
Floor: 1st Floor  
 Location: Office #34  
 Orientation: ceiling  
 Equipment: Flir B2

**Concerns:**  
 Further investigation of wall cavity is recommended due to moisture detected. Moisture readings are elevated and above acceptable levels.

Floor:1st Floor - LocationOffice #34 - Orientation:ceiling  
Equipment: Flir B2  
Problem: Further investigation of wall cavity is recommended due to moisture detected. Moisture readings are elevated and above acceptable levels.

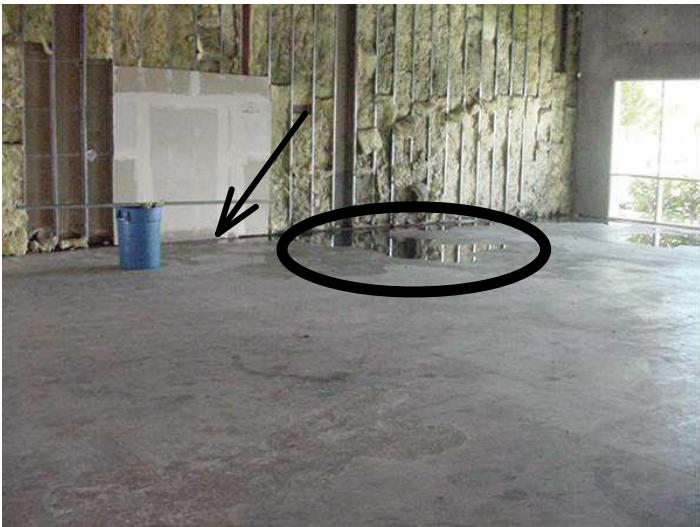
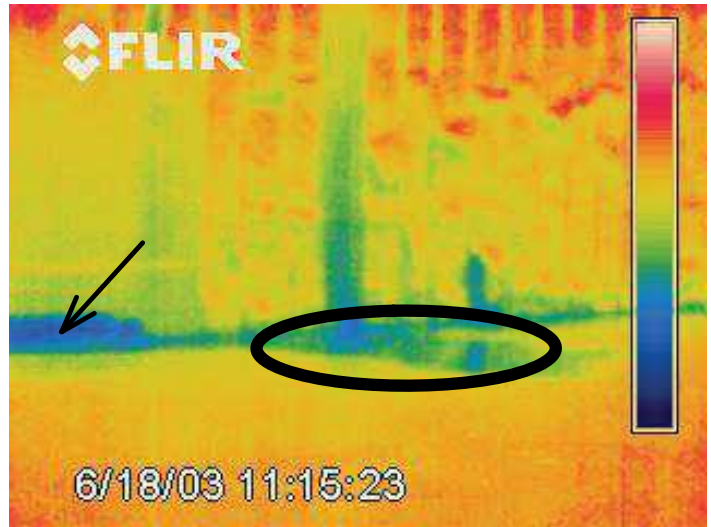
Floor: 1st Floor  
Location: Shop  
Orientation: Southwest  
Equipment: Flir B2

Concerns:  
Saturated wall cavity after fire. Wet/missing insulation, puddling at floor existing

Floor:1st Floor - LocationShop - Orientation:Southwest  
Equipment: Flir B2  
Problem: Saturated wall cavity after fire. Wet/missing insulation, puddling at floor exsisting

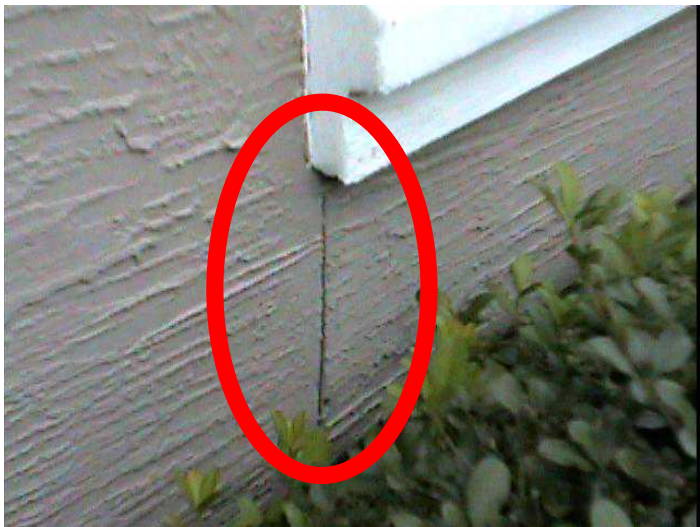
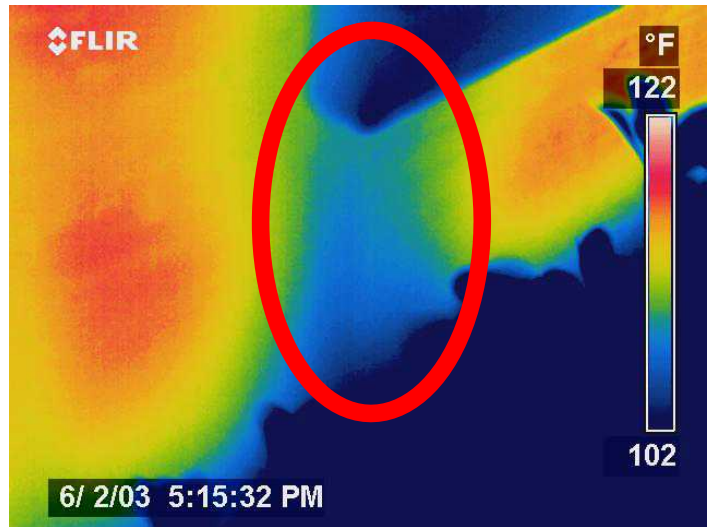
Floor: 1st Floor  
Location: Rear window  
Orientation: South Wall  
Equipment: Flir B2

Concerns:  
Moisture concerns detected. , Further investigation of wall cavity is recommended due to anomaly detected.

Floor:1st Floor - LocationRear window - Orientation:South Wall  
Equipment: Flir B2  
Problem: Moisture concerns detected. , Further investigation of wall cavity is recommended due to anomaly detected.

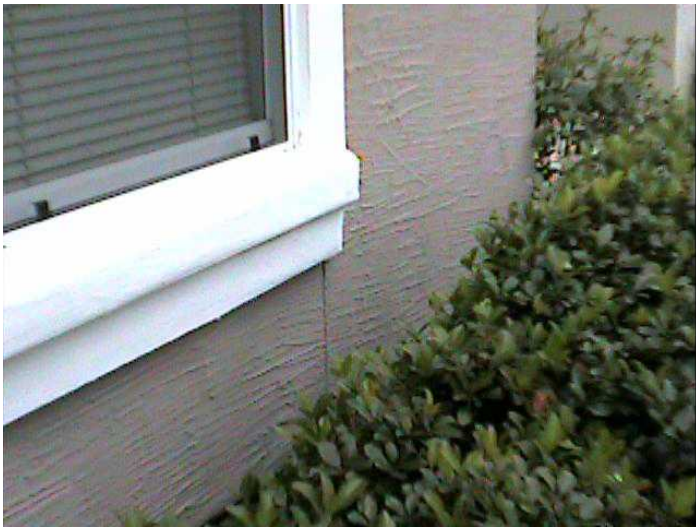
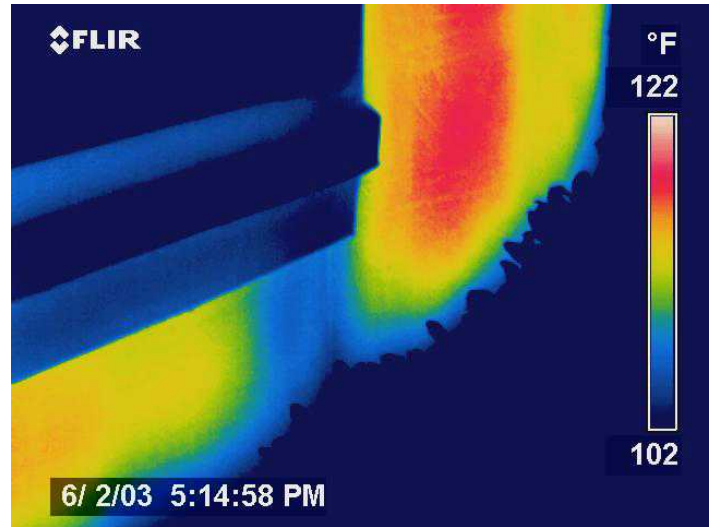
Floor: 1st Floor  
Location: Rear window  
Orientation: South wall  
Equipment: Flir B2

Concerns:  
Moisture concerns detected. , Further investigation of wall cavity is recommended due to anomaly detected.

Floor:1st Floor - LocationRear window - Orientation:South wall  
Equipment: Flir B2  
Problem: Moisture concerns detected. , Further investigation of wall cavity is recommended due to anomaly detected.
