Thermal Evaluation

1234 Madison Rd.
Anywhere, US 12345

Prepared for: John Smith

Prepared by: Your Company Name Here
1234 Any Street
Anywhere, US 12345
Visual report of findings.
Energy losses and moisture infiltration.

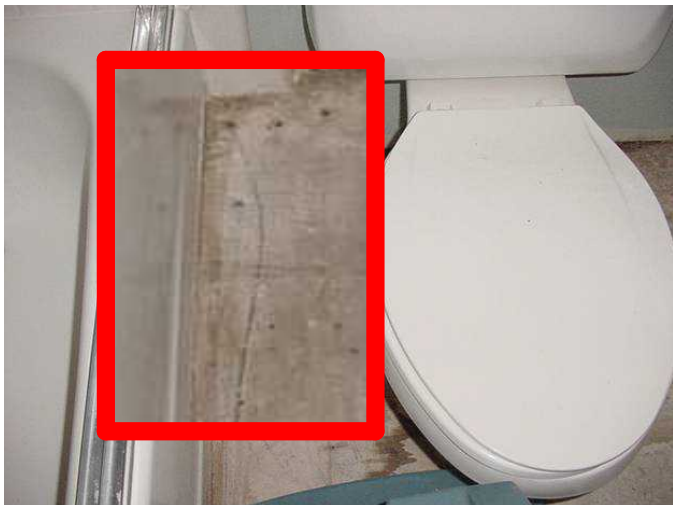
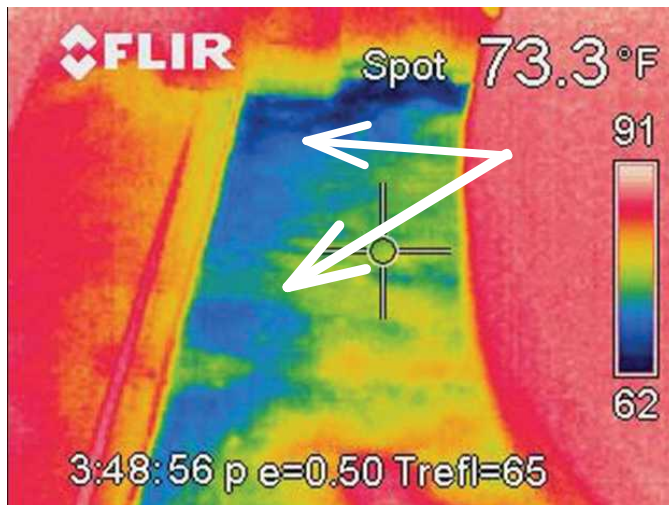
Location Floor: Interior
Location Room: 2nd Floor
Equipment: Flir ThermaCAM B2

Water damage detected from toilet leaking condition. Corrections are required to floor system including dry out and sanitizing.

Problem: Water damage detected from toilet leaking condition. Corrections are required to floor system including dry out and sanitizing.

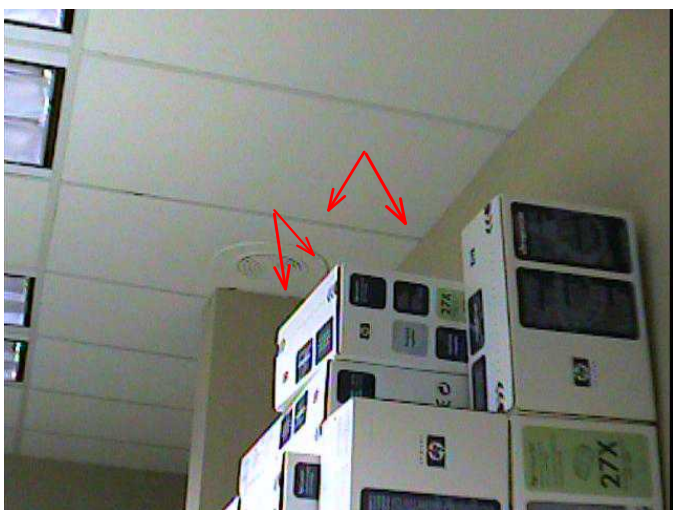
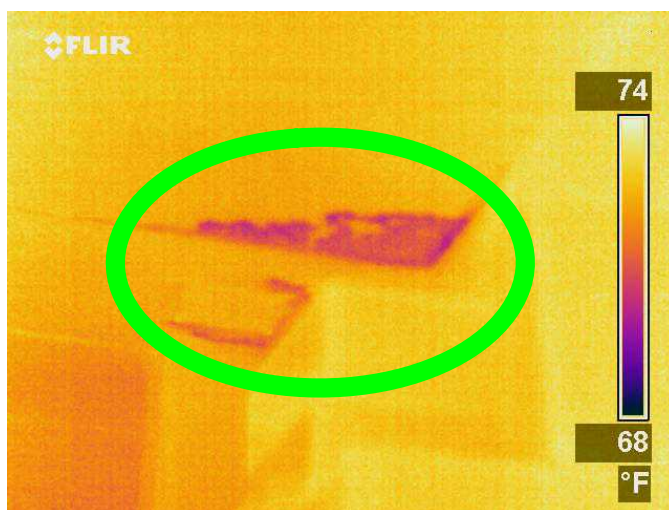
Location Floor: Interior
Location Room: Storage room
Equipment: Flir ThermaCAM B2

Water intrusion confirmed, Investigate and perform appropriate repair.

Problem: Water intrusion confirmed, Investigate and perform appropriate repair.

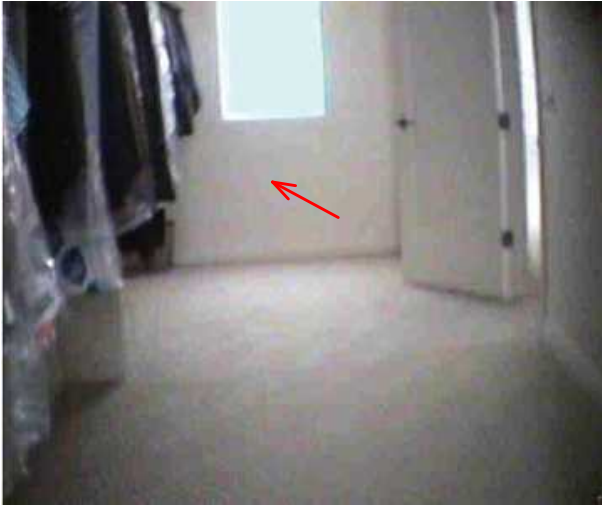
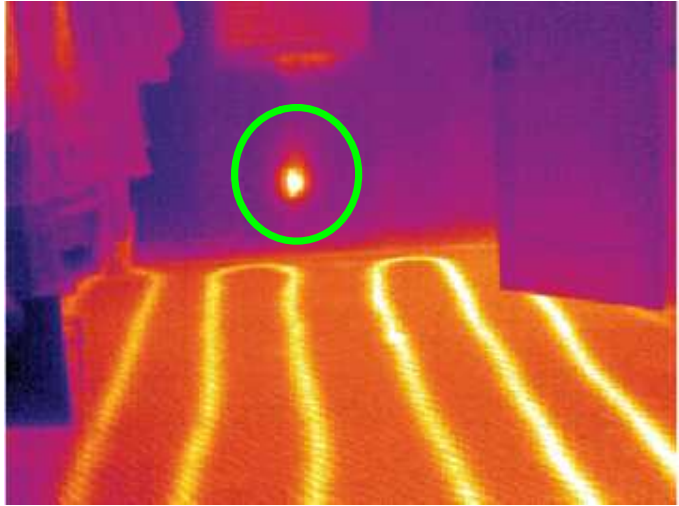
Location Floor: Interior
Location Room: Master Closet
Location Direction: South exterior wall
Equipment: Flir ThermaCAM B2

Insulation missing in wall cavity below window. Also noted in-floor convection heating system.

Problem: Insulation missing in wall cavity below window. Also noted in-floor convection heating system.

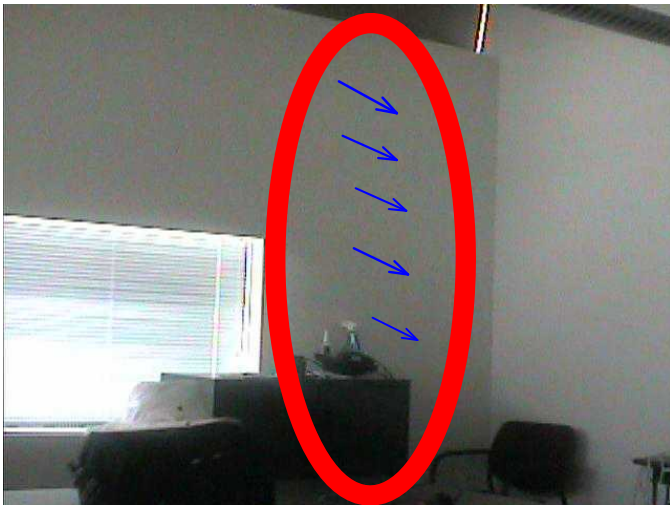
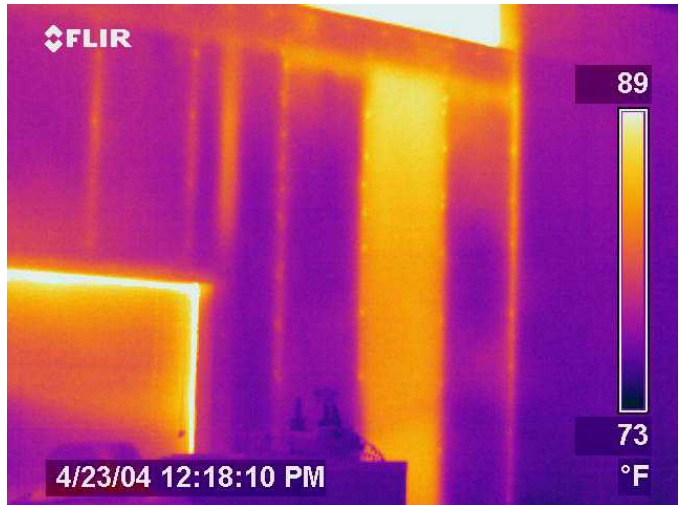
Location Floor: Interior
Location Room: Living Room
Location Direction: South Exterior Wall
Equipment: Flir ThermaCAM B2

Insulation missing in wall cavity

Problem: Insulation missing in wall cavity

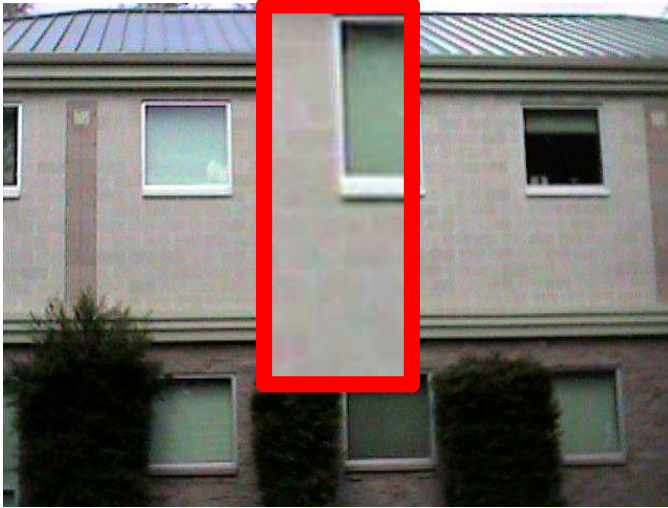
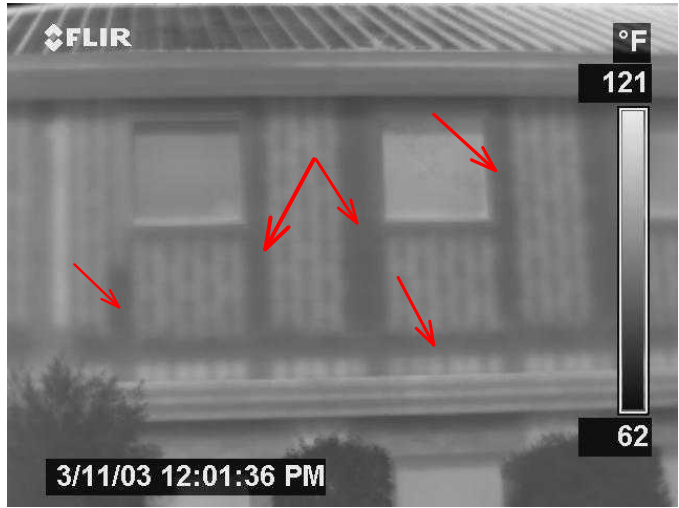
Location Floor: Exterior
Location Room: Rear
Location Direction: South Exterior
Equipment: Flir ThermaCAM B2

Observations:
Mortar missing in wall brick cavities

Problem: Mortar missing in wall brick cavities

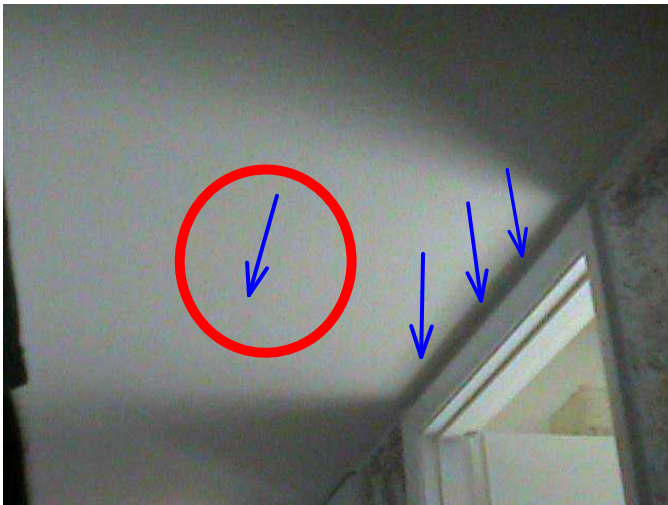
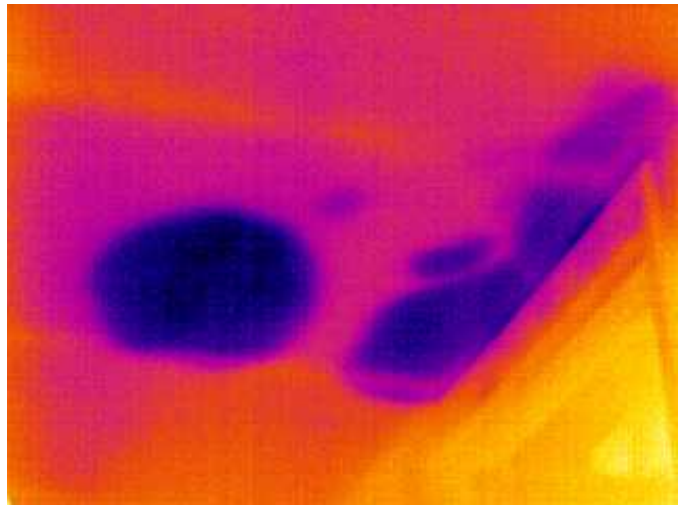
Location Floor: Interior
Location Room: Bathroom 2nd Floor
Equipment: Flir ThermaCAM B2

Observations:
Water intrusion confirmed, Investigate and perform appropriate repair.

Problem: Water intrusion confirmed, Investigate and perform appropriate repair.

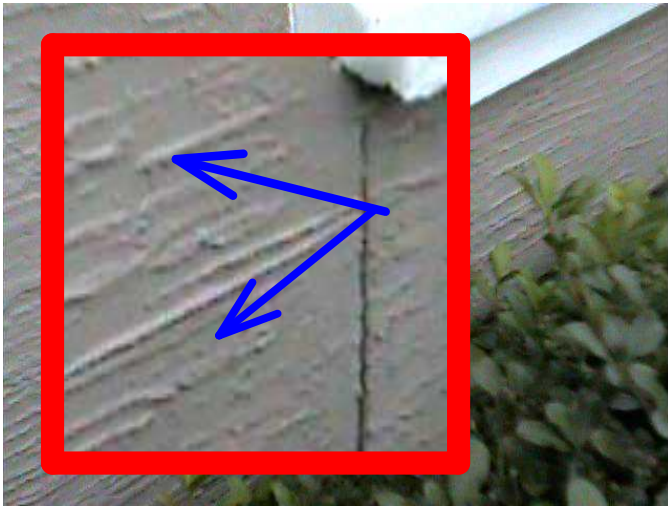
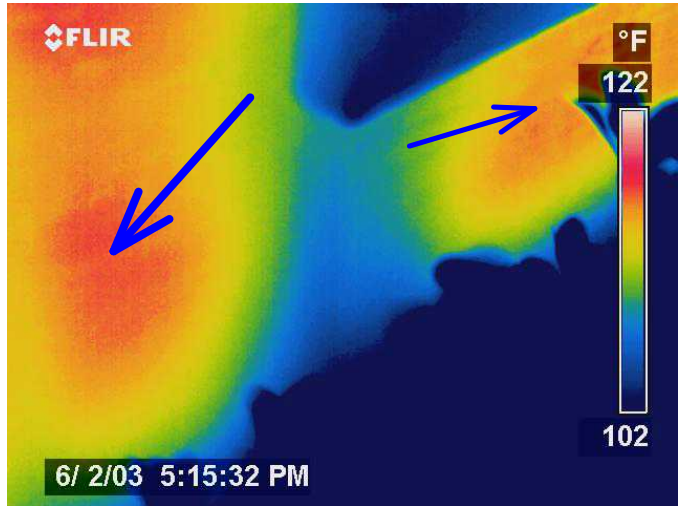
Location Floor: Exterior
Location Room: Living Room Window
Location Direction: South wall
Equipment: Flir ThermaCAM B2

Observations:
Insulation missing in wall cavity

Problem: Insulation missing in wall cavity
