Sample Energy Audit Report

5432 Anywhere St.
Somewhere, US 12345

Date:8/15/05
Time:8:00-10:30 am
Ambient Temperature:46 degrees
Wind Speed:2.5 mph
Relative Humidity:45%

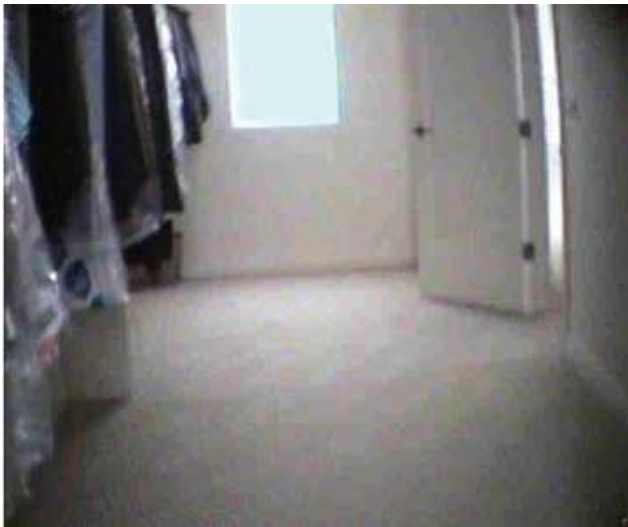
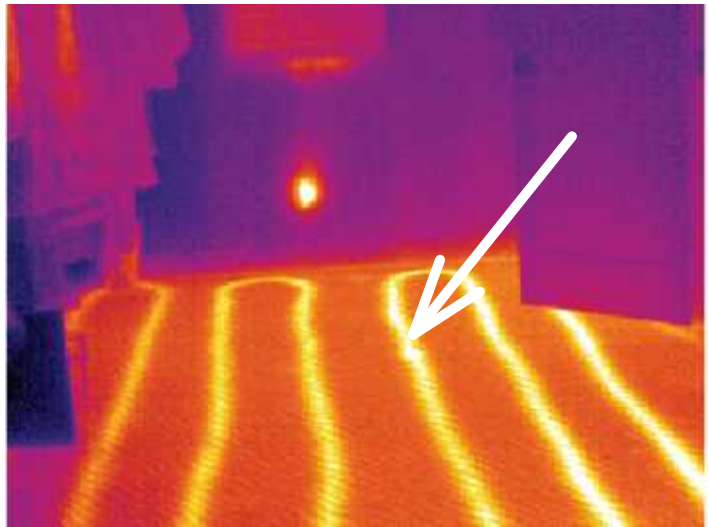
Floor: 2nd Floor
Location: Bedroom Closet
Orientation: South
Equipment: Flir B2

Concerns:
In floor heating system shown

Floor:2nd Floor - LocationBedroom Closet - Orientation:South
Equipment: Flir B2
Problem: In floor heating system shown

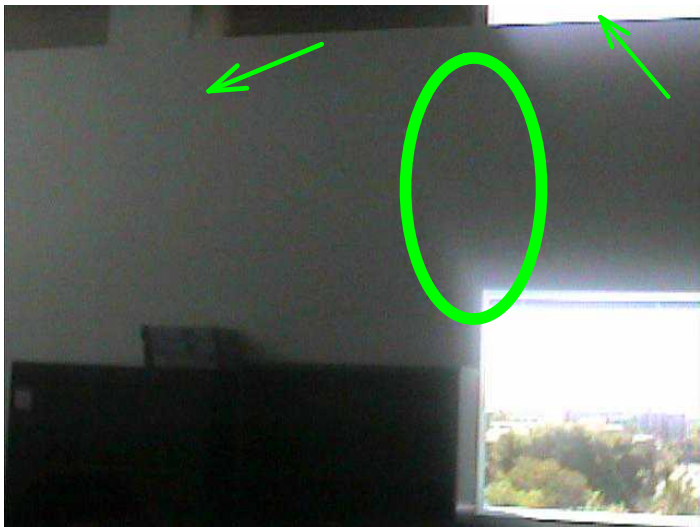
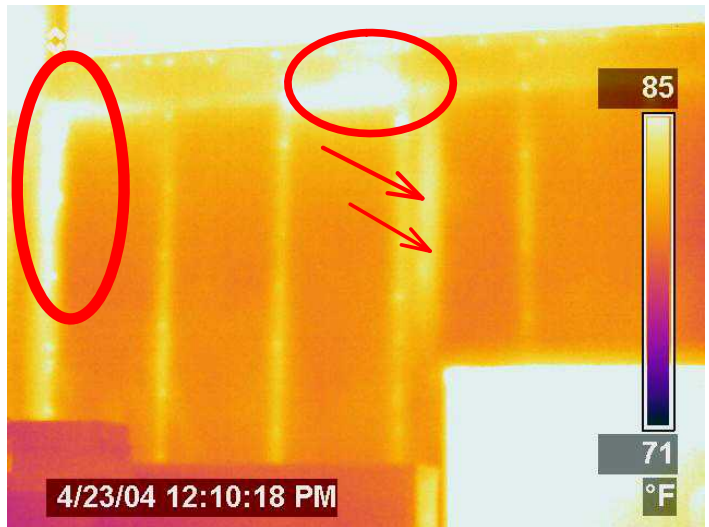
Floor: 1st Floor
Location: Living Room
Orientation: East
Equipment: Flir B2

Concerns:
Noted voids in thermal insulated wall areas

Floor:1st Floor - LocationLiving Room - Orientation:East
Equipment: Flir B2
Problem: Noted voids in thermal insulated wall areas

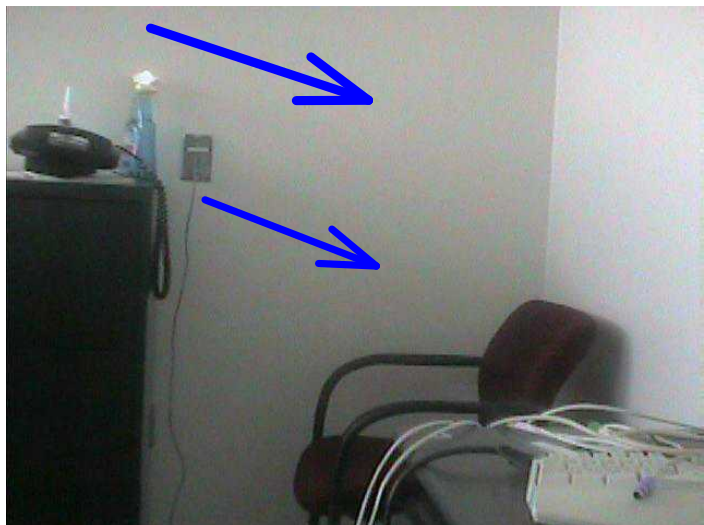
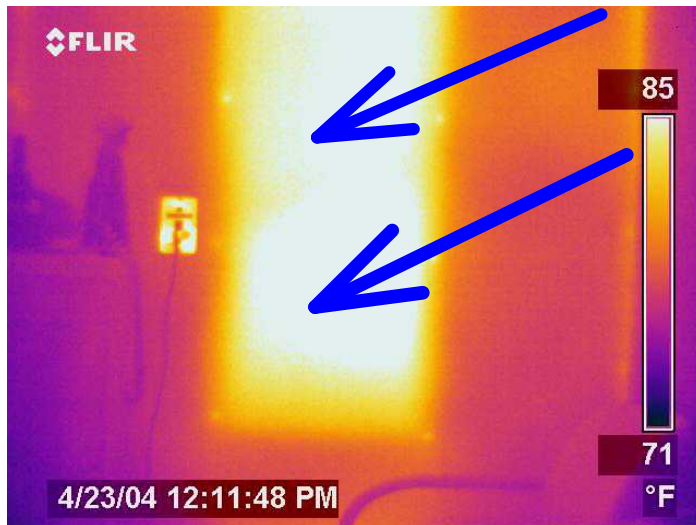
Floor: 2nd Floor
Location: Bedroom #2
Orientation: East
Equipment: Flir B2

Concerns:
Noted voids in thermal insulated wall areas.

Floor:2nd Floor - LocationBedroom #2 - Orientation:East
Equipment: Flir B2
Problem: Noted voids in thermal insulated wall areas.

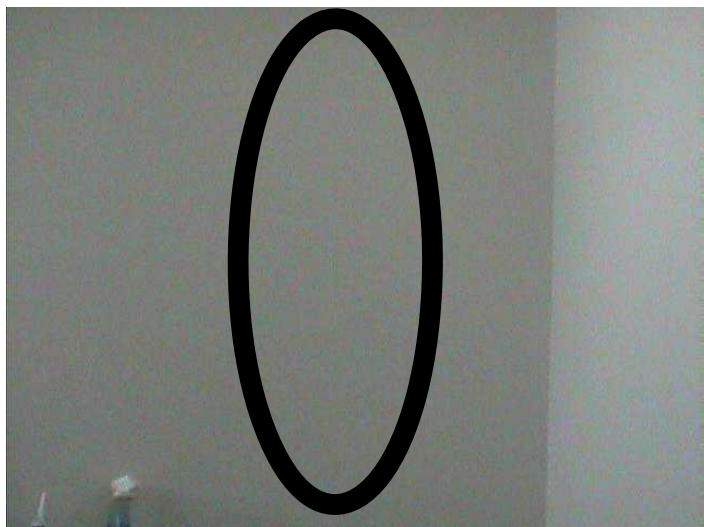
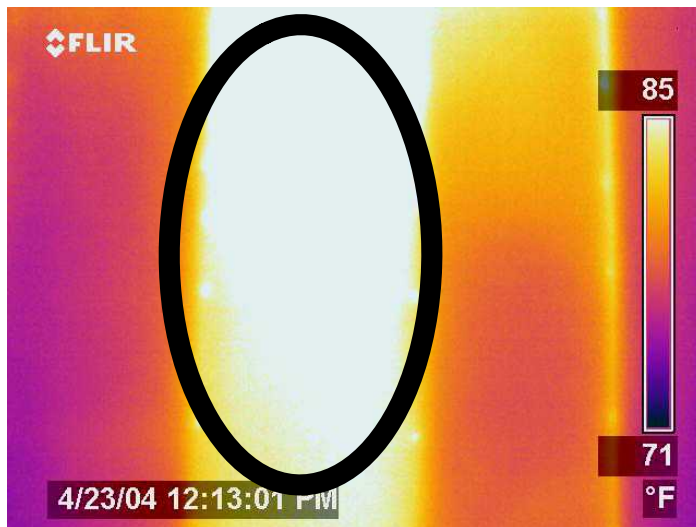
Floor: 2nd Floor
Location: Bedroom#2
Orientation: East
Equipment: Flir B2

Concerns:
Noted voids in thermal insulated stud wall cavity. Corrections are recommended.

Floor:2nd Floor - LocationBedroom#2 - Orientation:East
Equipment: Flir B2
Problem: Noted voids in thermal insulated stud wall cavity. Corrections are recommended.

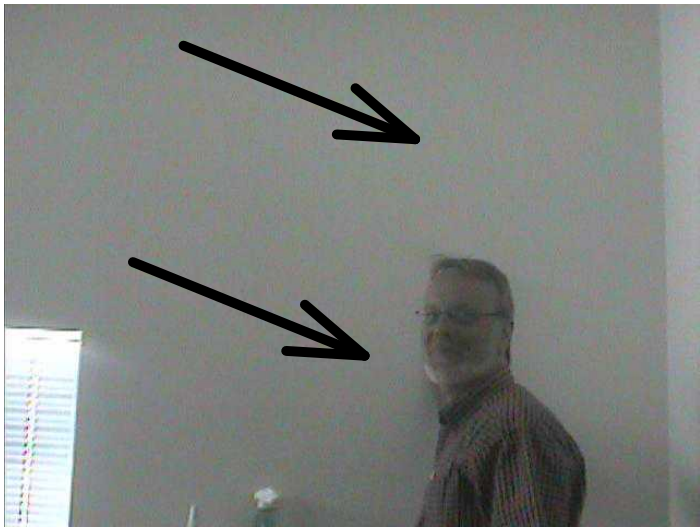
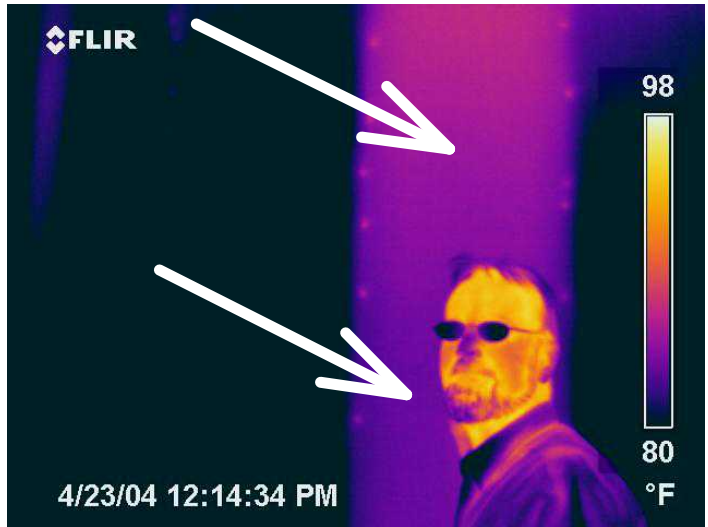
Floor: 2nd Floor
Location: Bedroom #2
Orientation: East
Equipment: Flir B2

Concerns:
Noted voids in thermal insulated stud wall cavity. Corrections are recommended.

Floor:2nd Floor - LocationBedroom #2 - Orientation:East
Equipment: Flir B2
Problem: Noted voids in thermal insulated stud wall cavity. Corrections are recommended.

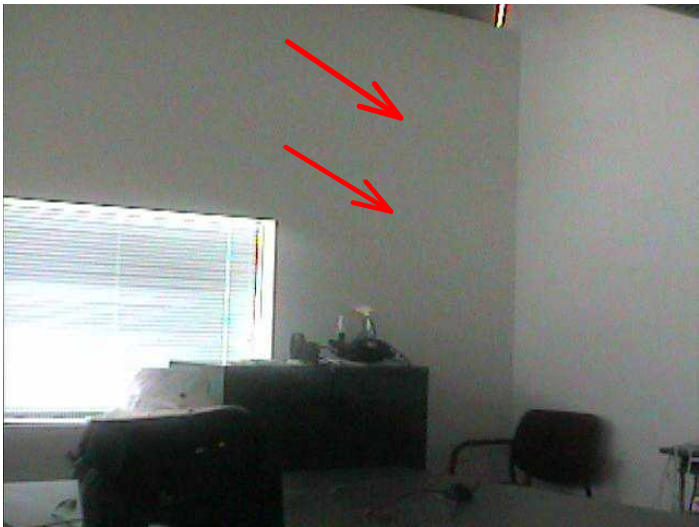
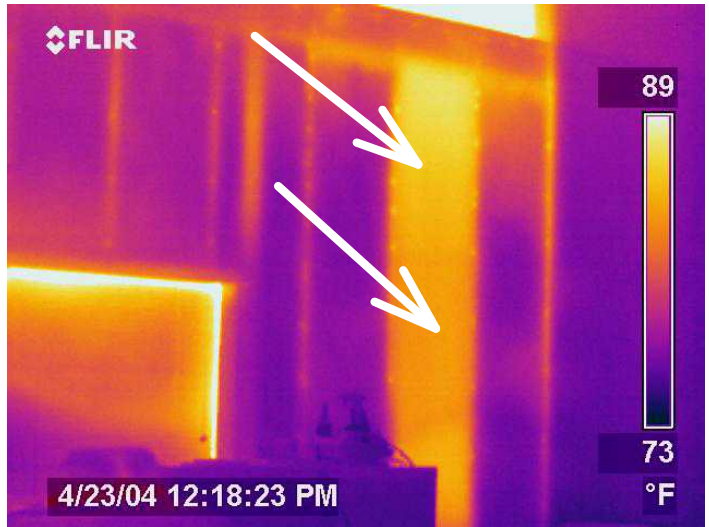
Floor: 1st Floor
Location: Living Room
Orientation: South
Equipment: Flir B2

Concerns:
Noted voids in thermal insulated stud wall cavity. Corrections are recommended.

Floor:1st Floor - LocationLiving Room - Orientation:South
Equipment: Flir B2
Problem: Noted voids in thermal insulated stud wall cavity. Corrections are recommended.

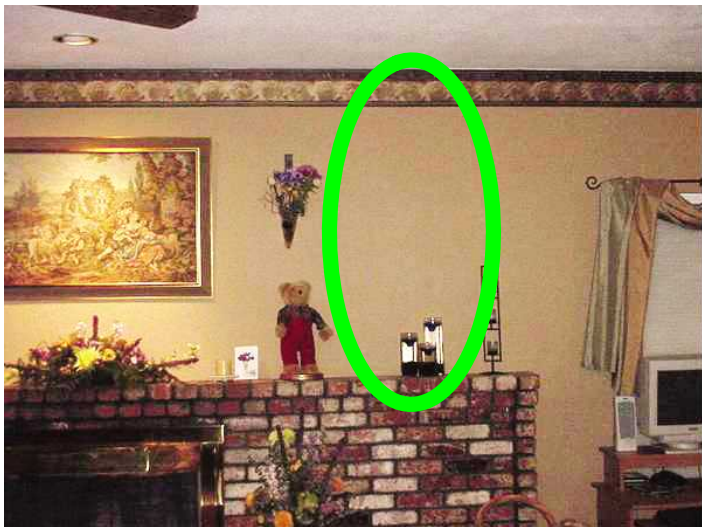
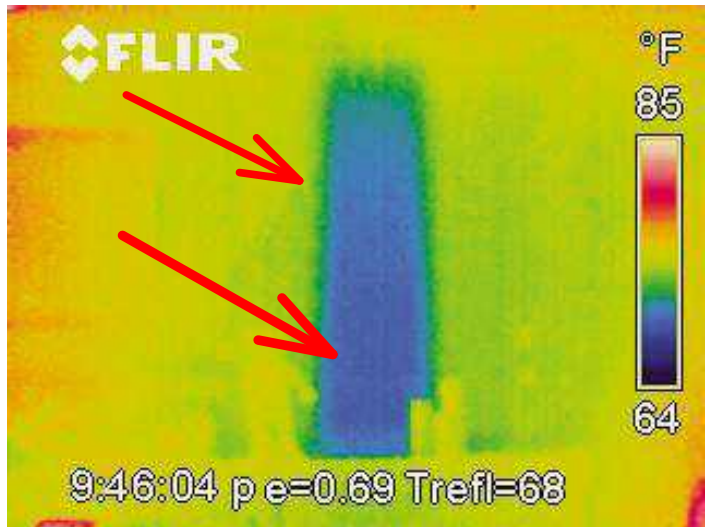
Floor: 1st Floor
Location: Living Room
Orientation: North
Equipment: Flir B2

Concerns:
Further investigation of wall cavity is recommended due to anomaly detected.

Floor:1st Floor - LocationLiving Room - Orientation:North
Equipment: Flir B2
Problem: Further investigation of wall cavity is recommended due to anomaly detected.
