Sample Energy Audit Report

5432 Anywhere St.
Somewhere, US 12345

Date:8/15/05
Time:8:00-10:30 am
Ambient Temperature:46 degrees
Wind Speed:2.5 mph
Relative Humidity:45%

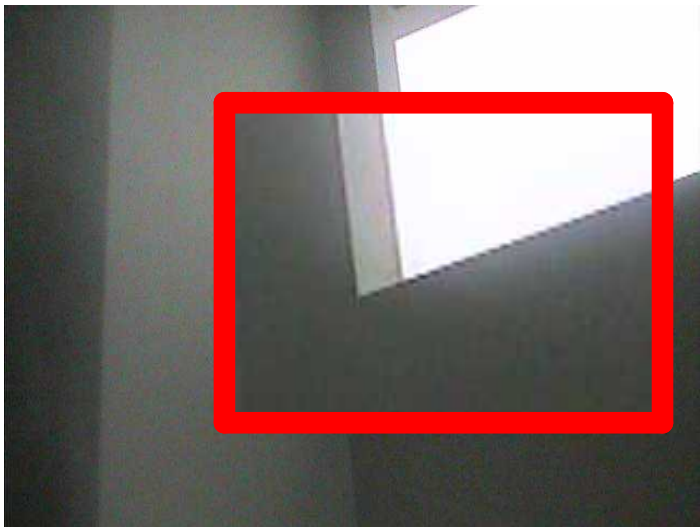
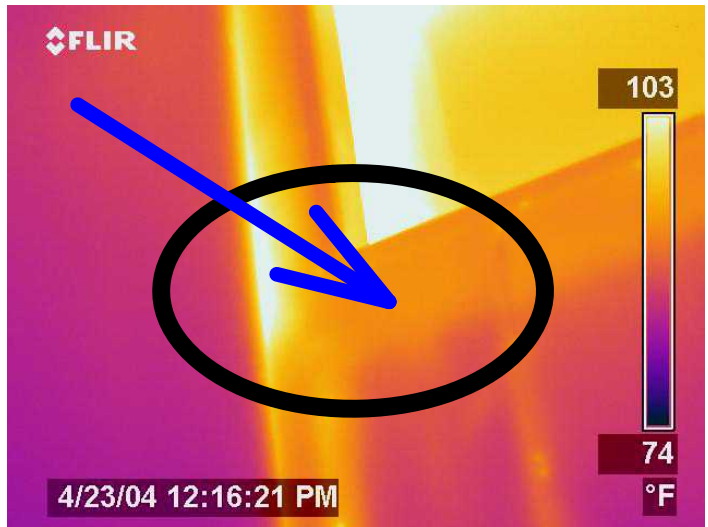
Floor: 2nd Floor
Location: Office
Orientation: Southwest
Equipment: Flir B2

Concerns:
Shot showing the EZmark zoom feature. DUAL-VIEW can also annotate your images using arrows and ellipses!
